FROM: Milone & MacBroom, Inc.

DRAFT DATE: July 26, 2016

RE: Dam Removal Feasibility Assessment

Clark Saw Mill Dam – Cabot, Vermont

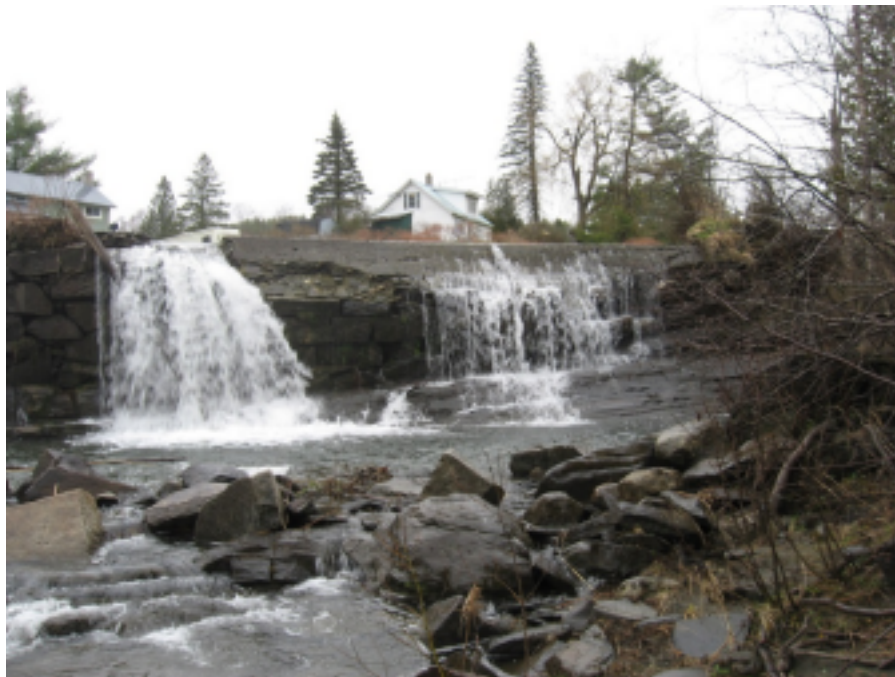
*Figure 2: Clark Saw Mill Dam (Looking Upstream on the Winooski River)
(Photo Taken by B. Cote, 5/5/2016)*

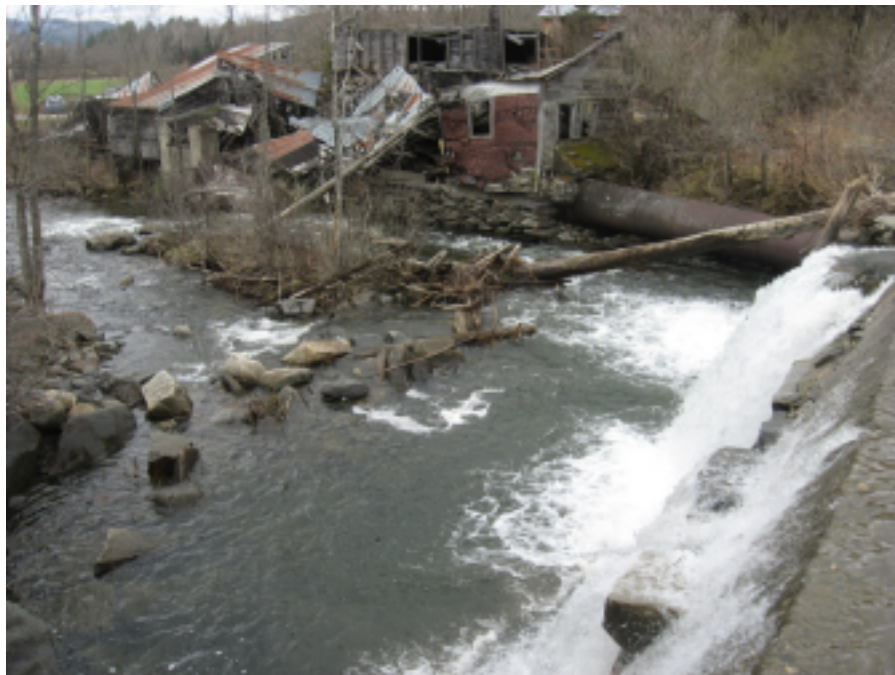
The unsafe, obsolete dam is owned by Headwaters Lumber Company, Inc. and is being considered for purchase and removal by the Town of Cabot. The collapsed former millworks on the right (facing downstream) side of the river downstream of the dam would also be removed (Figure 3).

Figure 3: Deteriorated Remains of the Clark Saw Mill (Looking Downstream from the Dam) (Photo Taken by B. Cote, 5/5/2016)
