Cabot Flood Study

Cabot, Vermont

SLR International Corporation

October 30, 2024

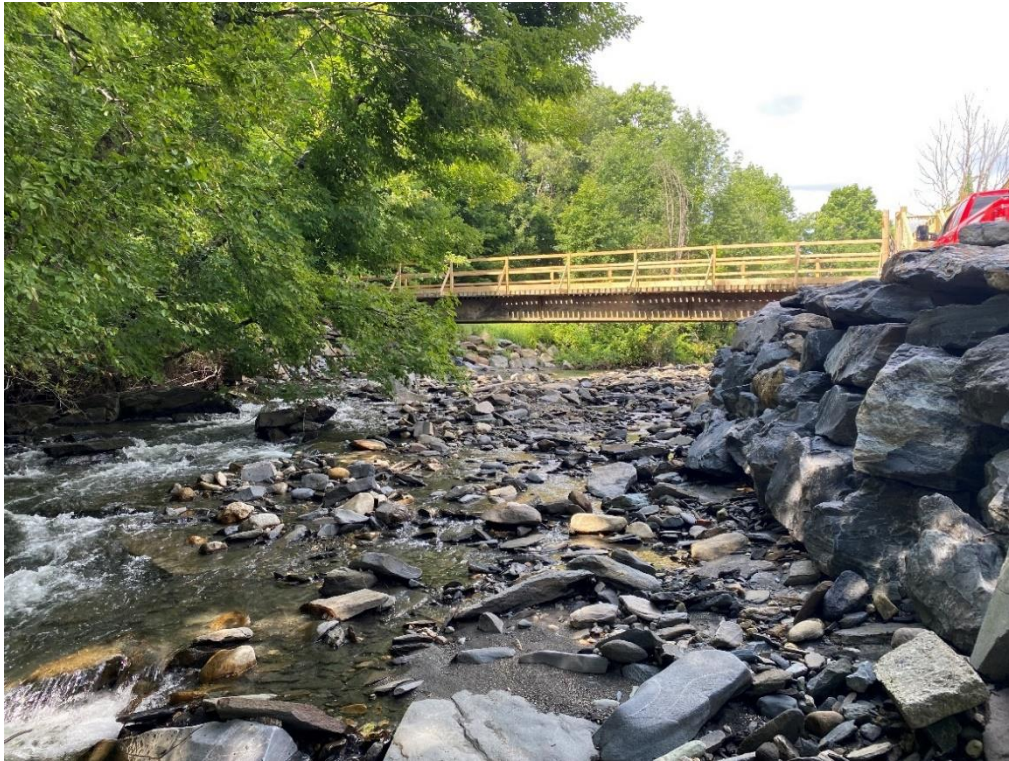
A VAST bridge crosses the Winooski River downstream of the Southern Tributary (Figure 4). The bridge span is 52 feet. The river channel under the bridge consists of a 30-foot bankfull channel and a 22-foot flood shelf. The vertical opening of the bridge is between 5.6 feet and 6.9 feet. The bridge beam is 3 feet deep.

Figure 4: VAST Bridge viewed from Downstream

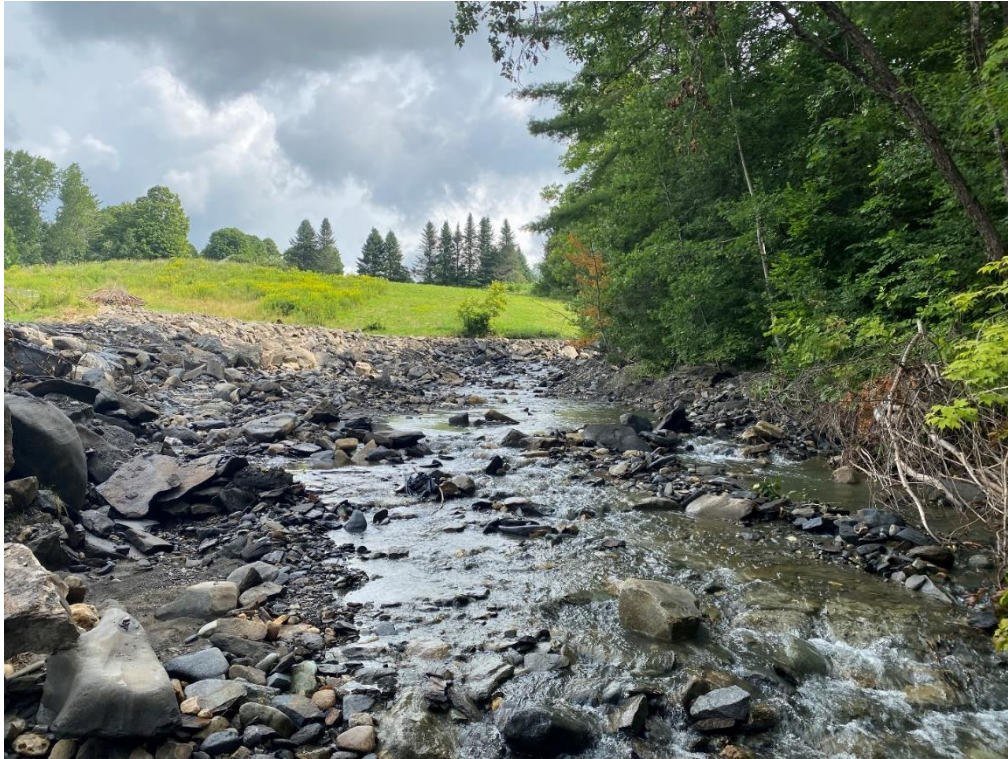
Moving upstream of the bridge the channel steepens to 3.7%, the bed material changes to boulders, bedrock, and cobble, and steps and pools are present near homes. The channel has been recently excavated around the meander upstream of the bend and is over-widened (bankfull channel width is 22.5 to 36.0 feet) (Figure 6). This area will serve as a catch for sediment and large wood in the next flood.

Figure 6: Northern Tributary in Over-Wide Area Post Dredging

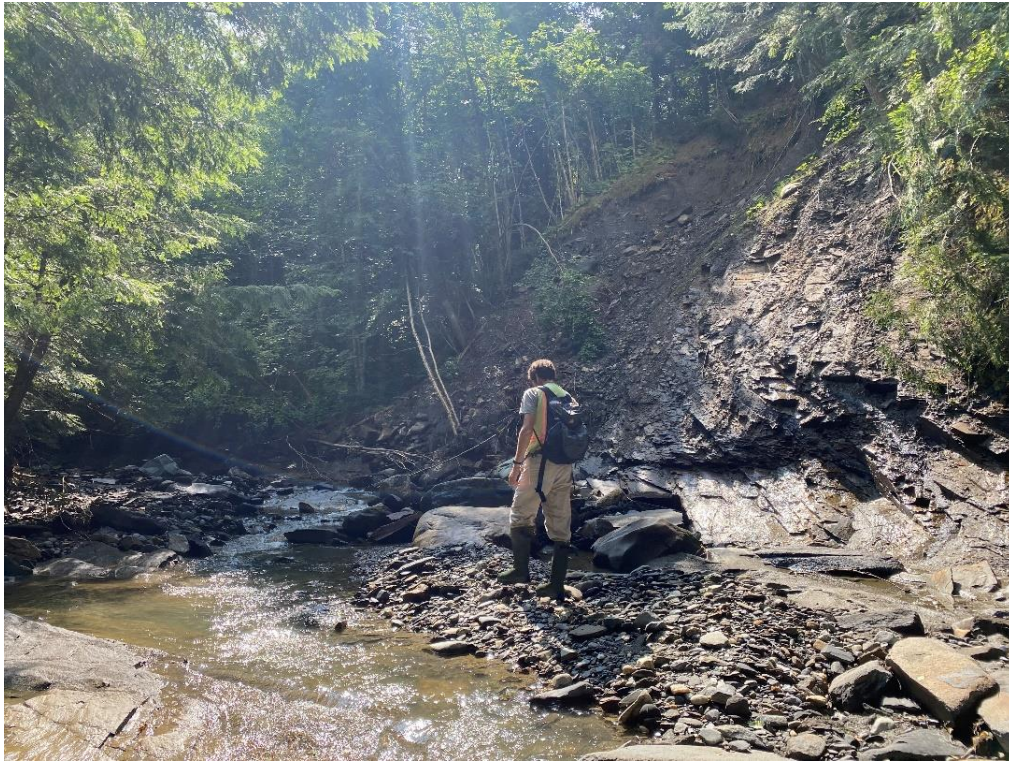
Figure 9: Mass Failure

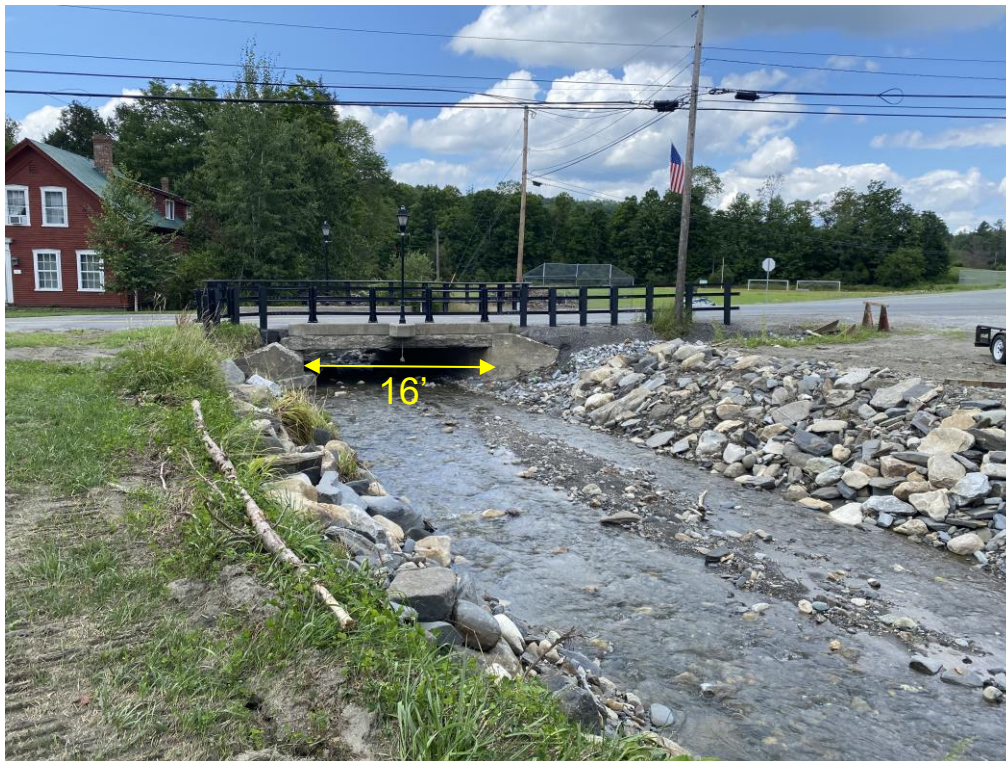
The Main Street Bridge, constructed in 1944, has a 16-foot span and is 25 feet wide (Figure 11). The height from the streambed to the bottom of the bridge beam (i.e., the low chord of the bridge) ranges from 3 to 4.5 feet at the upstream opening and 4 to 5 feet at the downstream opening. A vertical erosion face (i.e., a headcut) is moving upstream through the structure and was located at the downstream bridge opening during the stream walk. The channel is unstable in this area and the headcut is likely to move upstream during high flows.

The bridge is 72% of the bankfull channel width in the area (22 feet) with limited vertical clearance. The bridge constricts flow and does not fit the stream channel. Large wood clogged the bridge opening during the July 2023 flood. The existing opening does not provide space for debris to pass under the road. It has been reported that sediment has deposited in the channel around and under the bridge limiting its capacity. The bridge should be replaced with an appropriately sized structure to meet Vermont Stream Alteration Standards (VTANR, 2014) and Vermont River Management Standards (Schiff et al., 2014) – structure width = 100% to 120% bankfull channel width.

Figure 11: Main Street Bridge viewed from Upstream

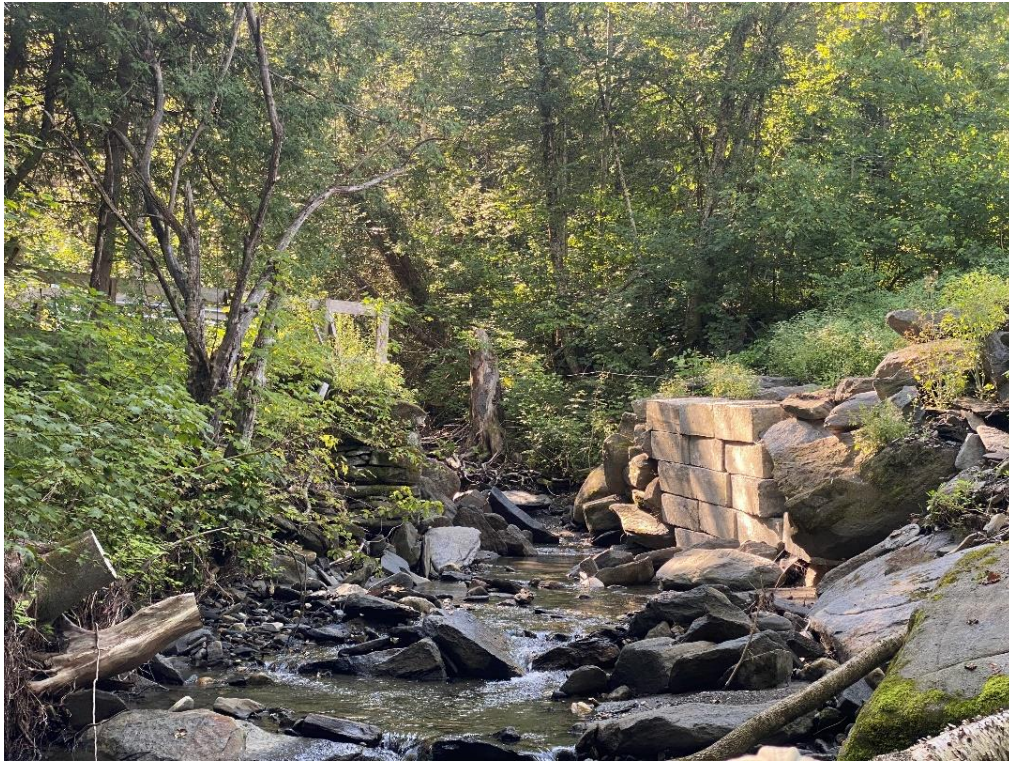
A strong constriction exists at the damaged VAST bridge that is 10 feet between stacked block abutments (Figure 13). The width between the abutments is about half of the bankfull channel width leading to a flood and erosion hazard. A large amount of sediment and large wood is bult up in the channel behind the abutments (Figure 14). The debris buildup is 5 feet tall in places and fills the full channel width. If the block abutments fail, this excessive accumulation would make its way to the village in a flood. This material should be removed from the channel and the abutments should be widened to 100% to 120% of the bankfull channel width.

Figure 13: Constriction at the Damaged VAST Bridge

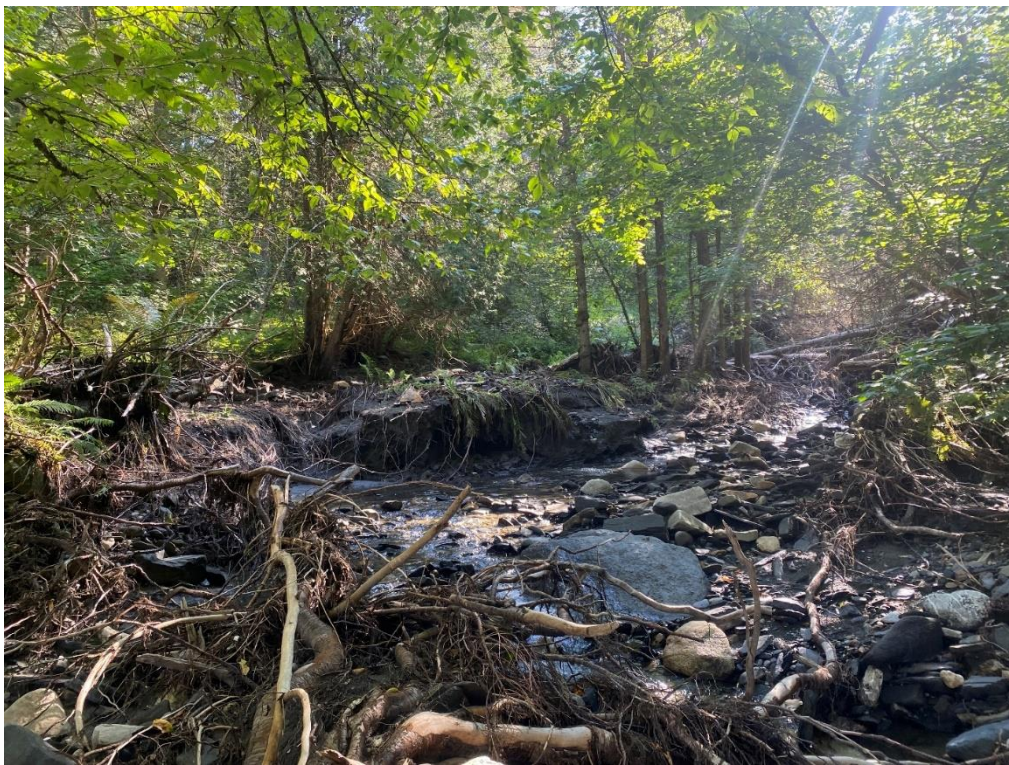
Figure 14: Sediment and Large Wood Accumulated Upstream of Damaged VAST Bridge

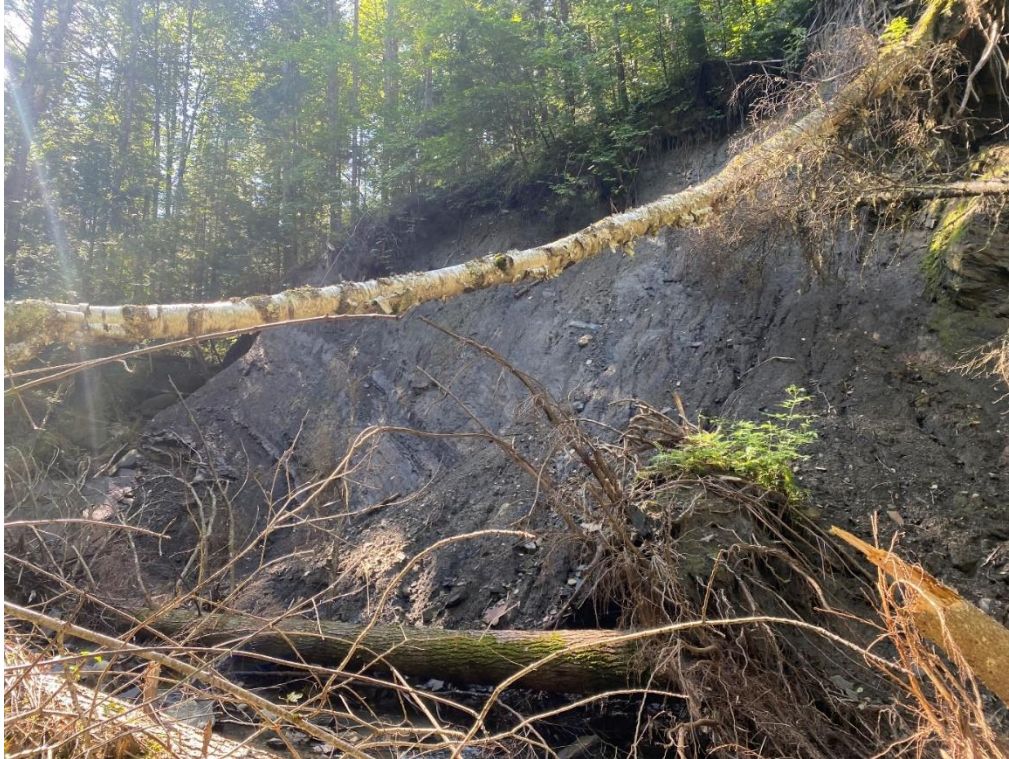
Moving upstream the Southern Tributary is comprised of many bedrock areas that are steep and narrow, coupled with wider areas of valley wall mass wasting where glacial till has eroded (Figure 15). These large erosion faces input sediment and large wood into the channel during flooding. Some of this material is temporarily stored in the channel by large wood jams that will periodically release and form during flooding (Figure 16). These stepped jams and storage areas are important to reduce downstream flood risk.

Figure 15: Mass Wasting on the Southern Tributary

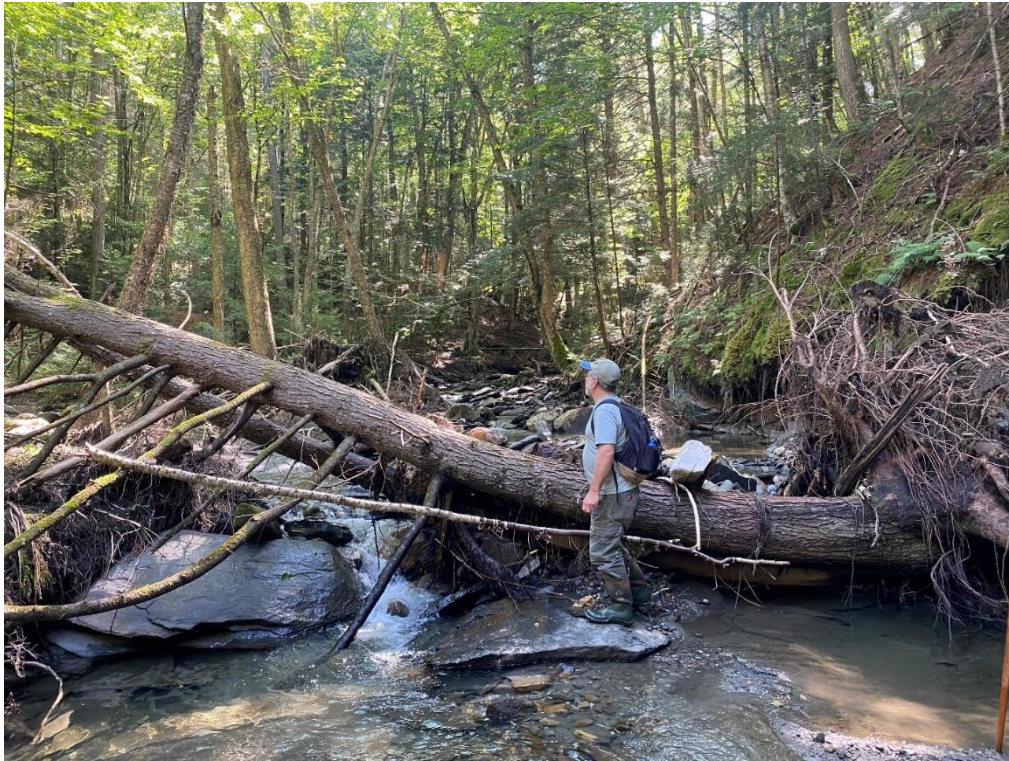
Figure 16: Sediment and Large Wood Storage Southern Tributary

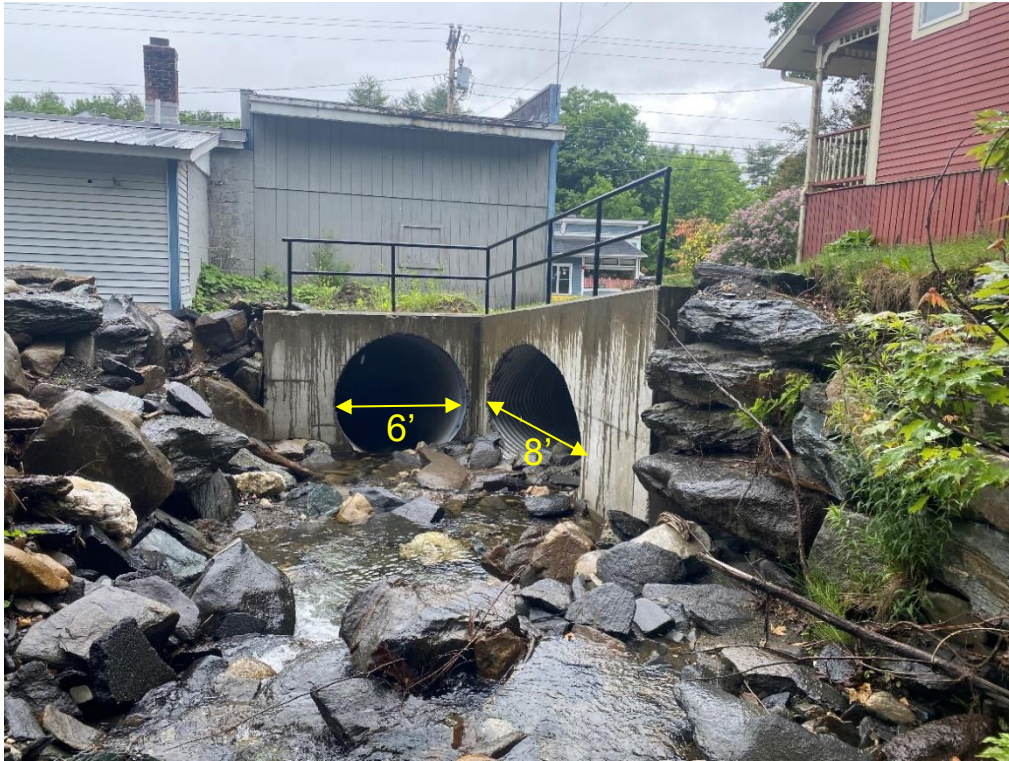
Two round corrugated metal culverts pass the Southern Tributary flow under Main Street (Figure 17). The left culvert is a 6-foot diameter round corrugated metal pipe that passes under the Cabot Garage. Its length is approximately 160 feet. The right culvert is a squashed corrugated metal pipe with an 8 foot span and 5.6 foot rise. The right culvert was installed to increase flood capacity after flooding from Tropical Storm Irene. The culvert angles to the north and then bends around the footprint of the Cabot Garage. Its length is approximately 172 feet.

The two culverts combined provide a total flow width of 14 feet; however, the severe skew of the right culvert reduces the effective hydraulic opening. The culverts are between 50% and 70% of the bankfull channel width, and thus are not likely to pass flood waters and debris. Past flooding illustrates that in this severely constricted setting, just a few pieces of wood or several boulders quickly clog the culvert openings.

Figure 17: Main Street Culverts viewed from Upstream

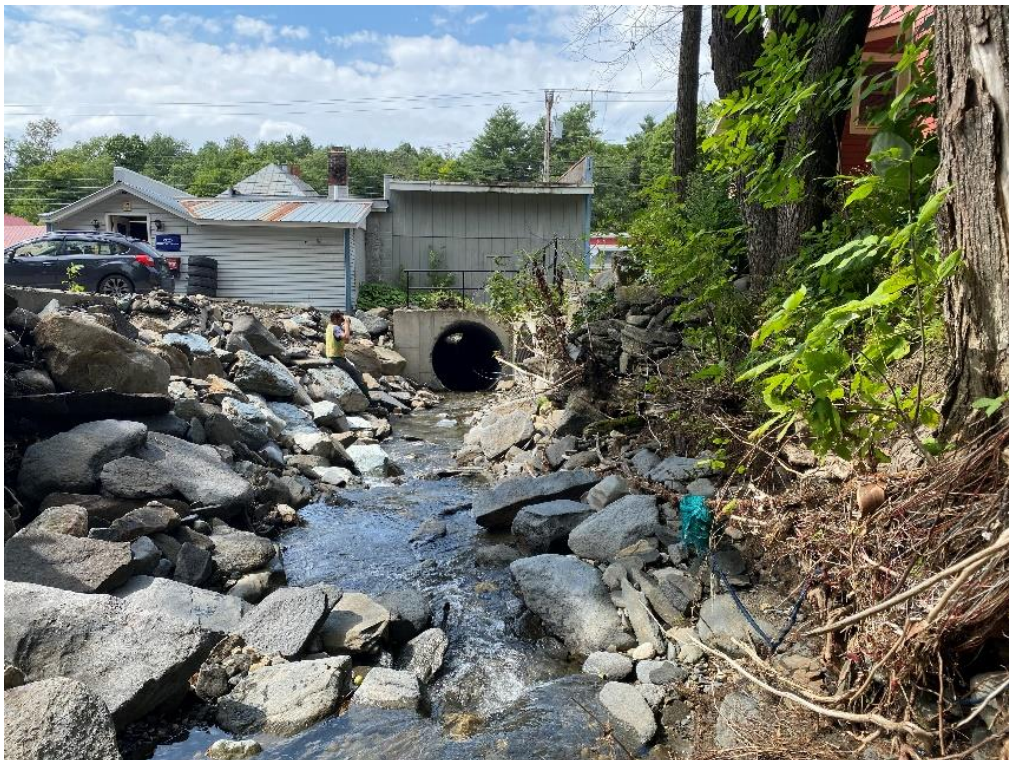
The channel approaching the culvert narrows from a natural bankfull channel width of approximately 20 feet to a width of 12 feet due to filling around buildings and parking lots (Figure 18). This channel is unable to carry flood flows from upstream along with sediment and large wood that move down river channels during flooding. Channel dimensions need to be naturalized as much as possible to safely pass floods into new structures and through the village.

Figure 18: Narrowed Channel Upstream of the Main Street Culverts

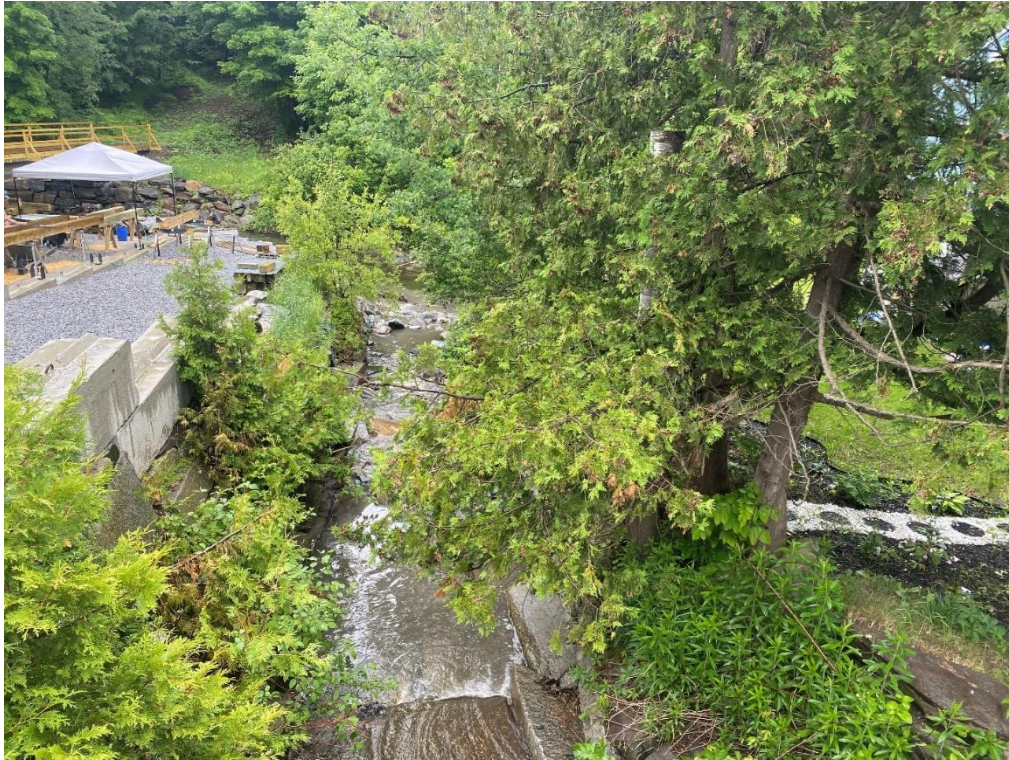
The channel downstream of the culverts is narrow (~ 14 feet wide) and steep at 5.2% as it passes between two buildings heading to the confluence with the Winooski River (Figure 19). As is the case upstream, this channel is unable to contain and pass flood flows with sediment and large wood during flooding. Channel dimensions need to be naturalized as much as possible to safely move floods out of the Southern Tributary and into the Winooski River. Given the space limitations due to the buildings, flood walls may be needed to widen the channel to match a larger structure at Main Street.

Figure 19: Narrowed Channel Downstream of the Main Street Culverts

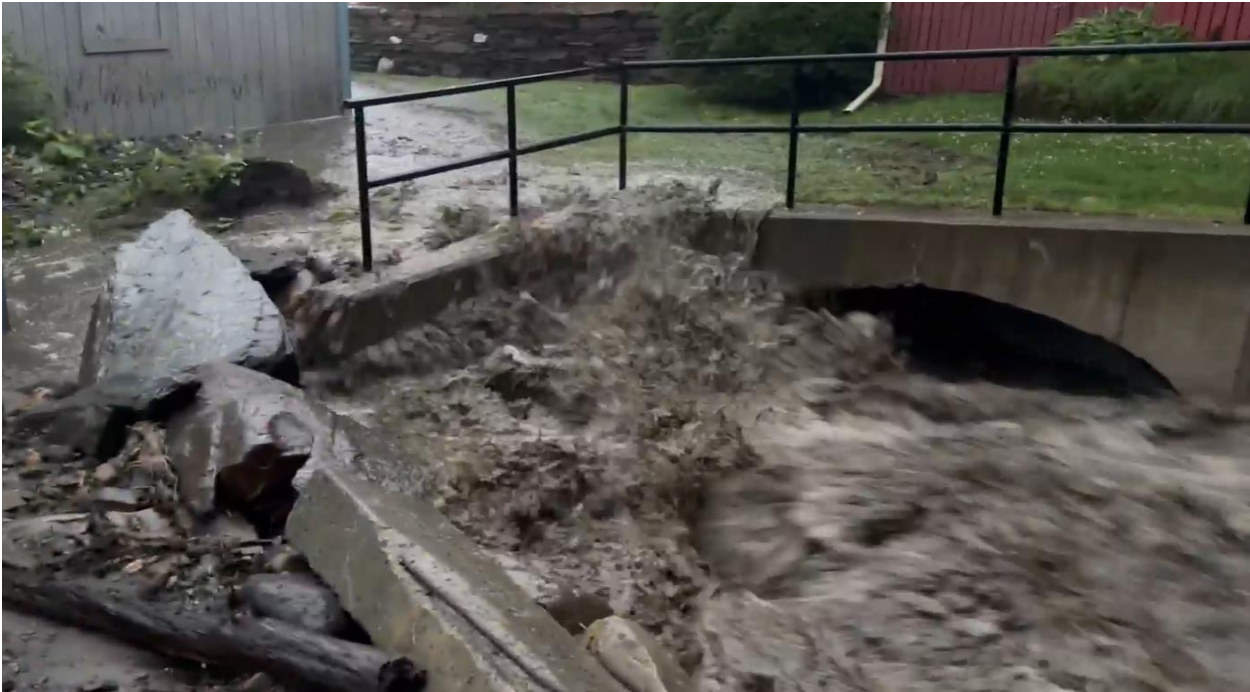
Photos and videos of the Southern Tributary culverts show that water was filling up the left culvert and just overtopping to flow around the garage and onto Main Street (Figure 21). The top of the left culvert is at elevation 1059.2 ft NAVD88 and the modeled peak flood water surface elevation is at EL 1059.3 ft. The plan view of the modeled flood velocity shows a flow pattern that matched the photo around the Cabot Garage (Figure 22).

Figure 21: Flood waters overtopping culverts

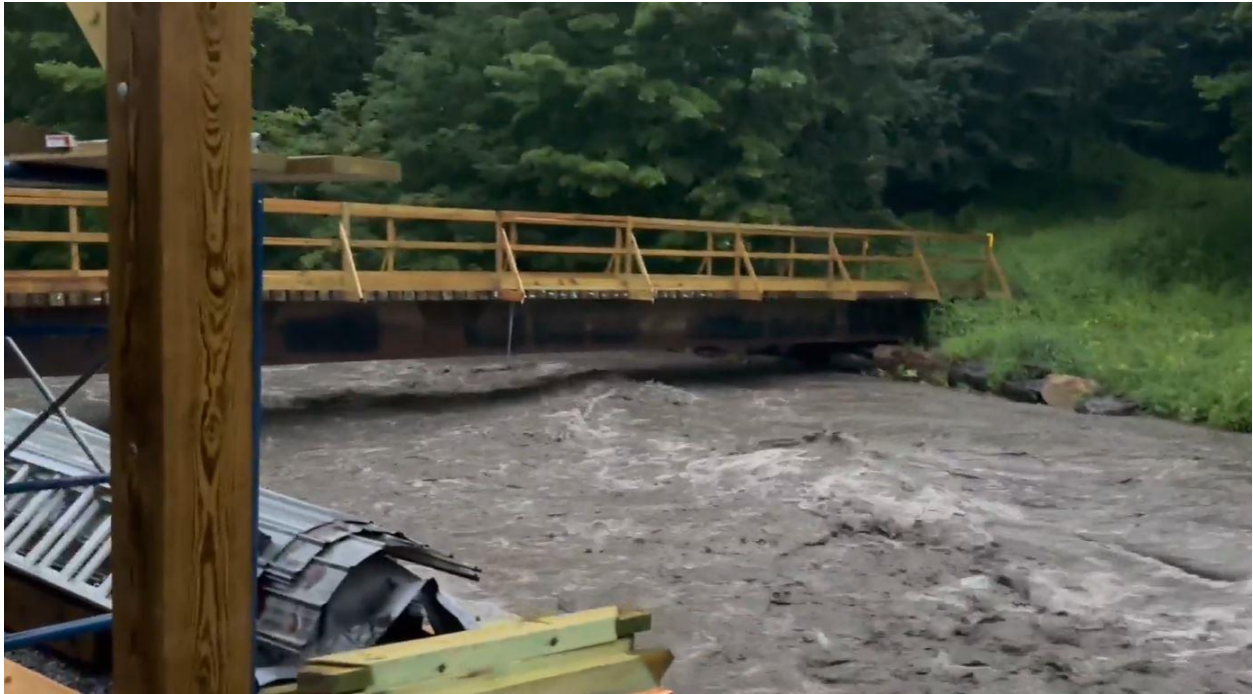
Model results on the mainstem of the Winooski River were compared to images of the flood waters passing under the VAST bridge. The photo shows the flood water approximately 1.5 to 2 feet below the 3-foot deep steel beams (Figure 23). Model results found that the water surface under the bridge is approximately 1.8 feet below the steel beams for the 100-year flood (Figure 24).

Figure 23: Flood waters passing under the VAST bridge

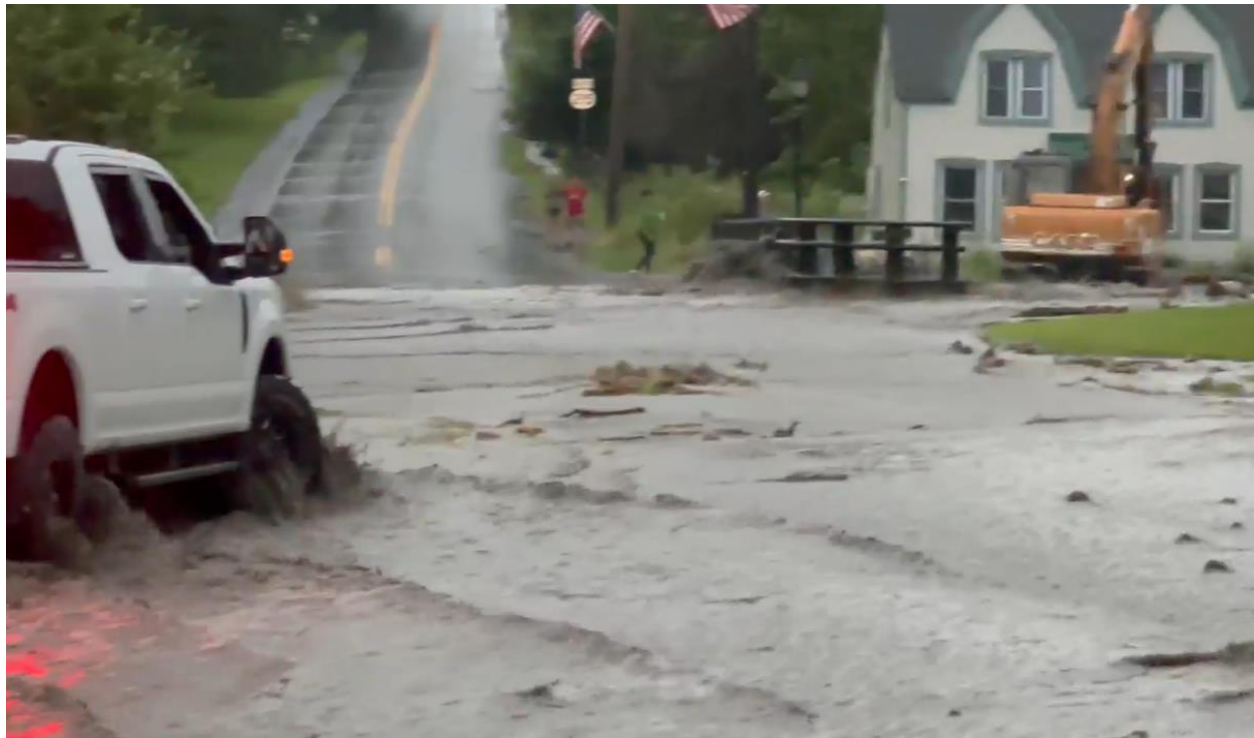
Images of the Northern Tributary overtopping the bridge under Main Street compare well to the 100-year flood modeling results. The bridge overtopped and flow travelled down Main Street (Figure 25). Modeling results found that the left side of the bridge is overtopped by approximately 1 foot during the 100-year flood (Figure 26). These validation results indicate that the accuracy of the model is appropriate for evaluation of alternatives to understand relative changes to flood patterns associated with various flood mitigation options.

Figure 25: Northern Tributary flood waters overtopping the Main Street Bridge and flowing down Main Street

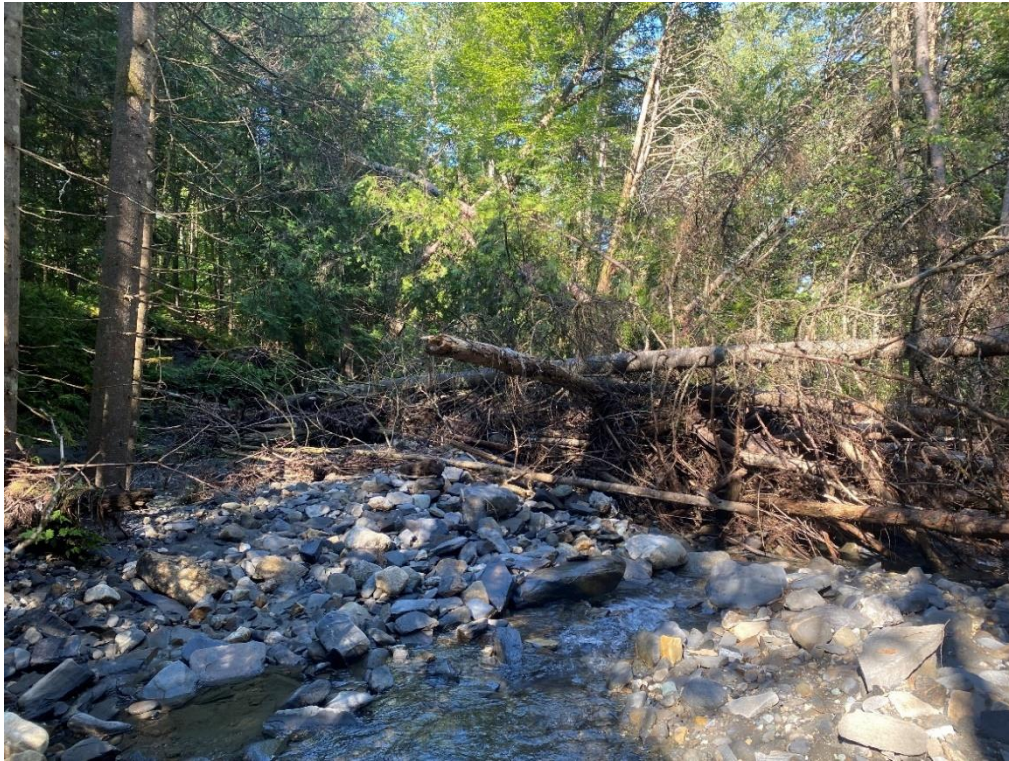
Upstream of the undersized abutments a significant amount of sediment deposition has occurred and several large wood jams have developed (Figure 27). The strong constriction of the abutments has caused a damming effect impounding water during high flows and causing sediment and debris to settle out. Sediment has deposited across the valley, girdling and killing trees, and filling in the natural stream channel. Field measurements estimated that the quantity of impounded sediment is between 2,000 and 3,500 cubic yards.

The built up sediment and large wood is a major hazard to the downstream culverts. A failure of the bridge abutments could release thousand of yards of debris that would quickly clog the culverts and flood the village. It is recommended that the bridge abutments be widened to fit the channel and the sediment and large wood be removed from this location. All of these steps should take place in the same time frame.

Figure 27: Large wood jam and sediment deposition upstream of the abutments

Upstream on the Southern Tributary it is recommended that the VAST bridge abutments be widened to fit the channel and the sediment and large wood be removed. This buildup of wood and large sediment pose a hazard to the downstream culverts and will continue until the VAST bridge is replaced.
