# Cabot Flood Study

## Cabot, Vermont

**SLR International Corporation**

October 30, 2024

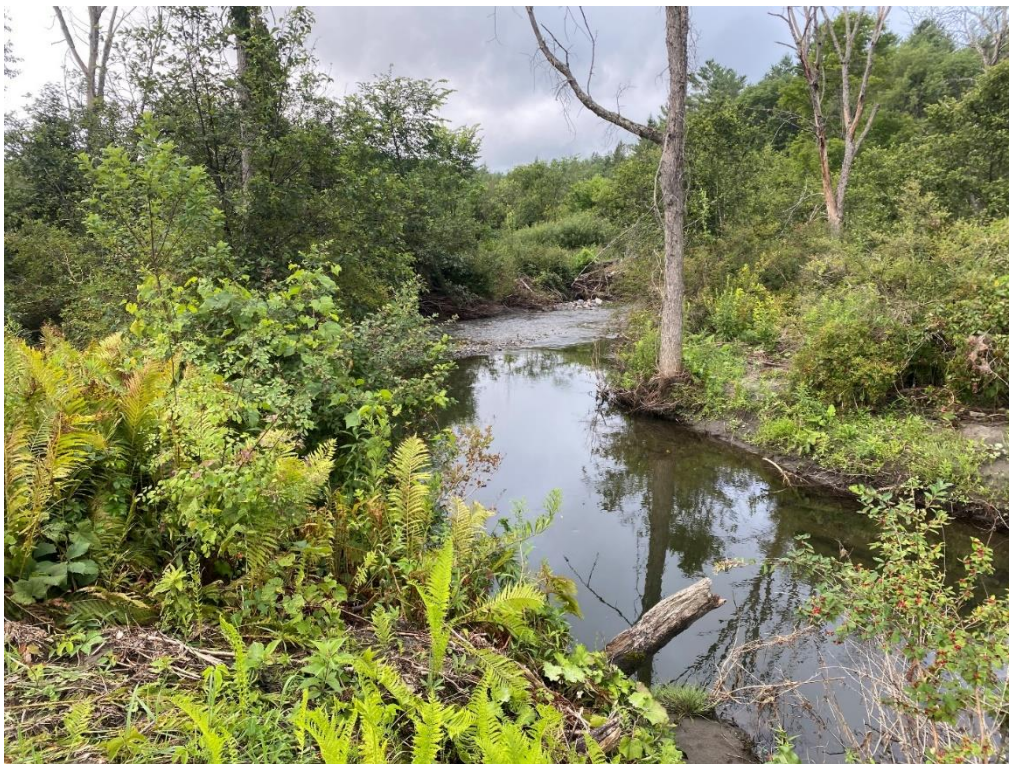
**Figure 3: Winooski River just Upstream of Northern Tributary**

The bankfull channel width on the Winooski River is 25 feet at the Northern Tributary and 30 feet at the Southern Tributary. The channel bed material is dominated by cobble and gravel, but also contains boulders, sands, and finer particles.

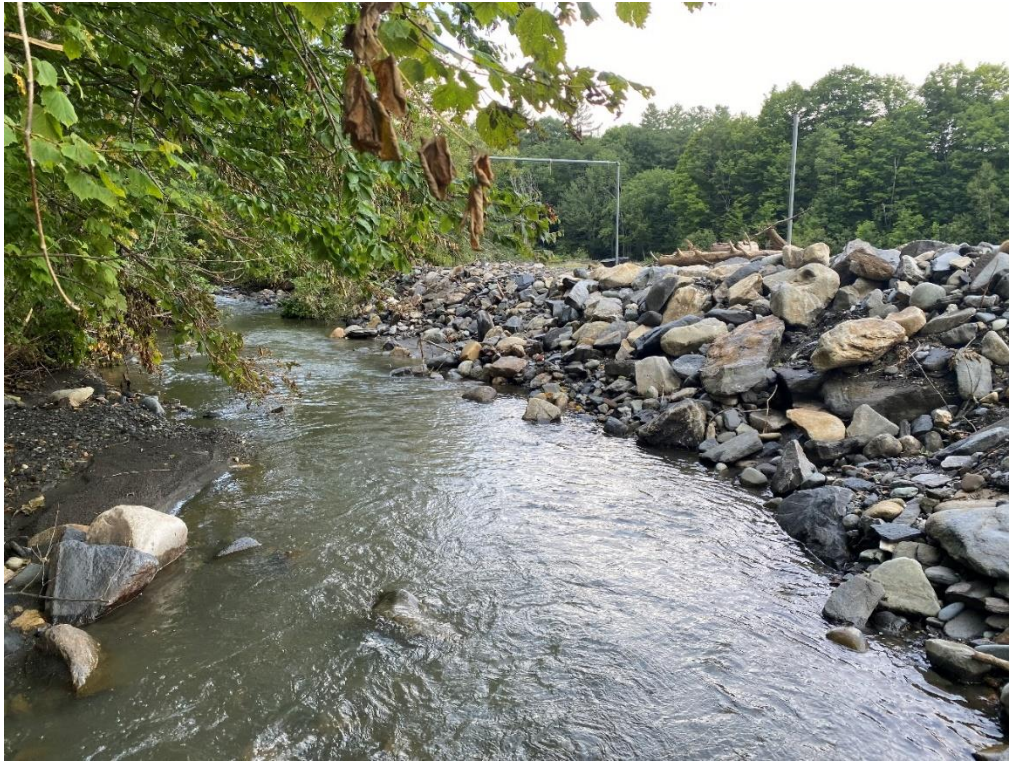
The Northern Tributary consists of a flatter 2.6% slope riffle-pool channel from the Winooski River confluence to the Main Street Bridge. The channel appears to have been recently dredged and some berming has taken place along the recreation fields (Figure 5). The channel bed material in this area is typically dominated by cobble, boulder and gravel; yet in the dredged area the channel is smoother and dominated by gravel. Gravel is building up in the post-dredge channel, the gravel is soft under foot, and the channel is less stable with signs of bank erosion.

**Figure 5: Northern Tributary along the Recreation Fields**

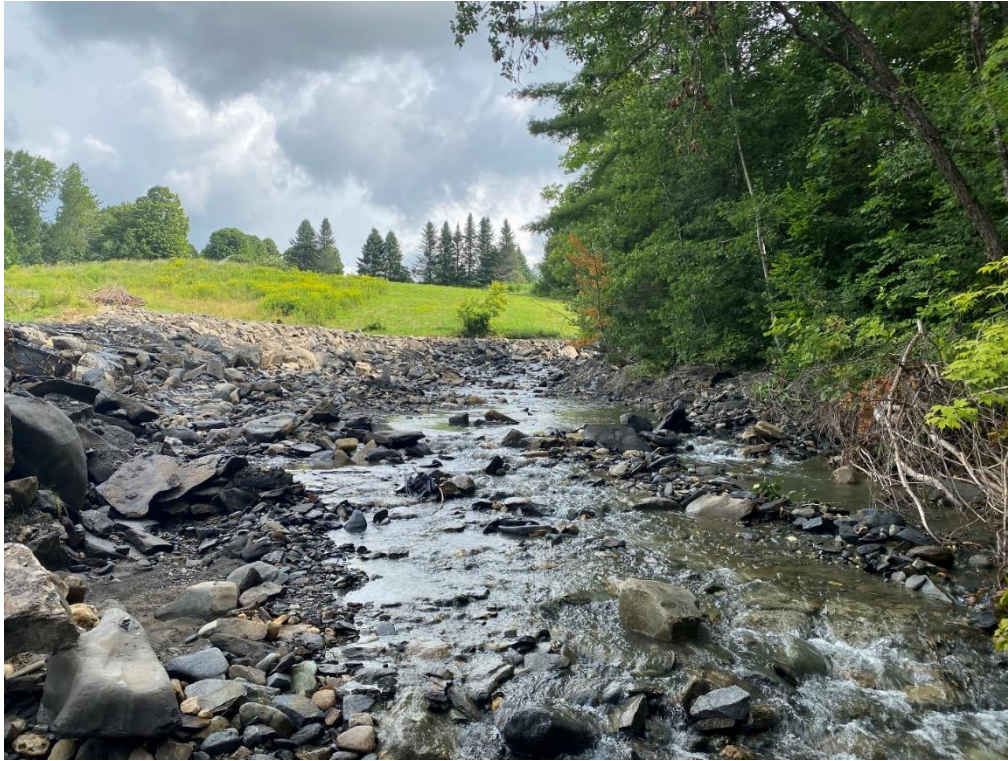
Moving upstream of the bridge the channel steepens to 3.7%, the bed material changes to boulders, bedrock, and cobble, and steps and pools are present near homes. The channel has been recently excavated around the meander upstream of the bend and is over-widened (bankfull channel width is 22.5 to 36.0 feet) (Figure 6). This area will serve as a catch for sediment and large wood in the next flood.

**Figure 6: Northern Tributary in Over-Wide Area Post Dredging**

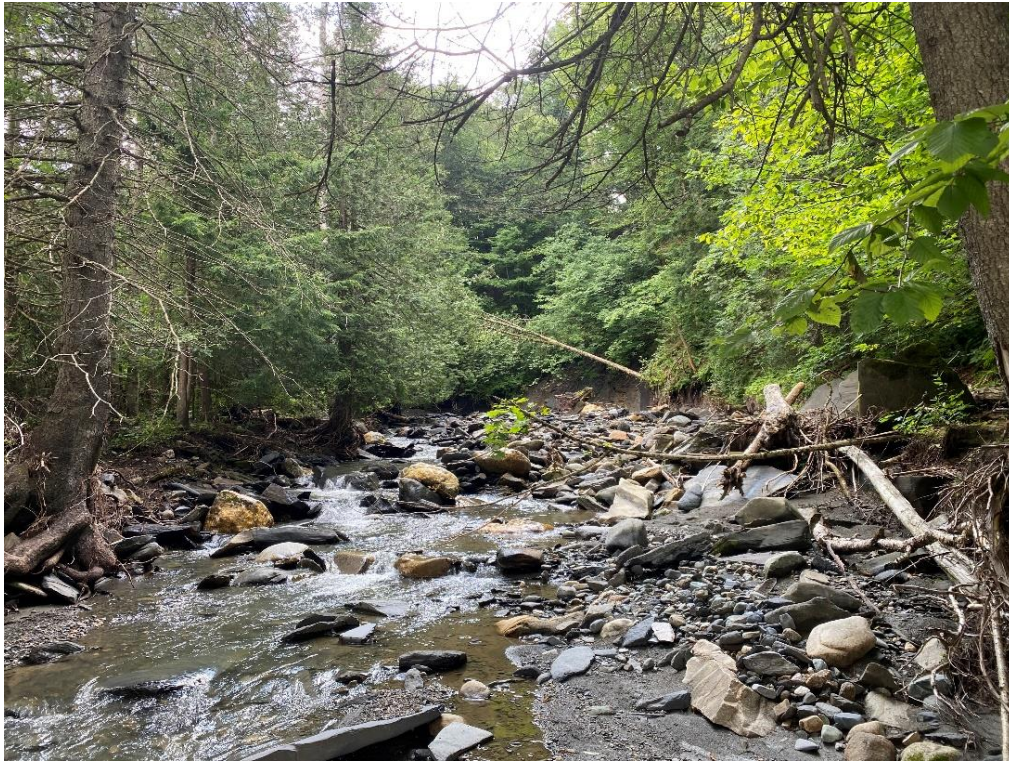
Moving upstream the channel enters the forest, narrows, and steepens to 4.1% (Figure 7). The bankfull channel width decreases and is in the range of 16.5 to 21.0 feet (Table 1). The channel often contains bedrock on the bed and banks, as well as dense glacial till (Figure 8). The bedrock narrows store large sediment between floods. Periodic land slides exist where the base of the dense till was eroded and the overlying tall bank collapsed (Figure 9). The mass failures are a source of sediment and large wood into the channel, some of which makes its way to the Main Street Bridge in the village and some of which is stored in the channel behind intermittent debris jams and on small flood shelves along the channel (Figure 10). These features are important to regulate the amount of material headed to the village during a single flood event.

**Figure 7: Northern Tributary Entering Forest Moving Upstream**

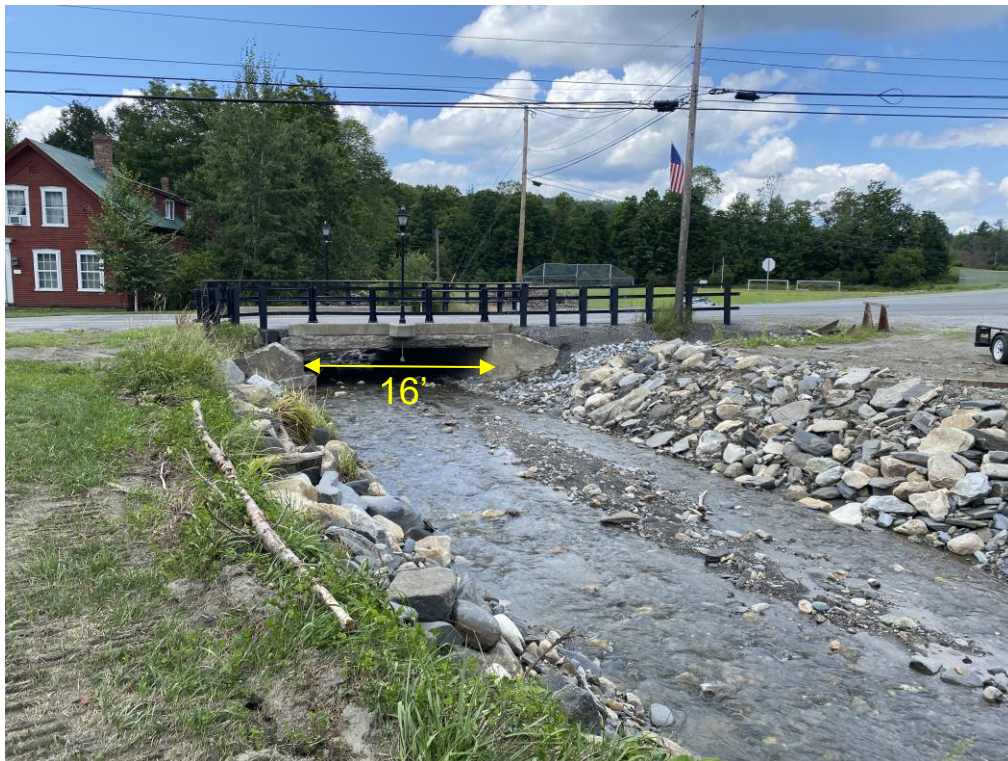
The Main Street Bridge, constructed in 1944, has a 16-foot span and is 25 feet wide (Figure 11). The height from the streambed to the bottom of the bridge beam (i.e., the low chord of the bridge) ranges from 3 to 4.5 feet at the upstream opening and 4 to 5 feet at the downstream opening. A vertical erosion face (i.e., a headcut) is moving upstream through the structure and was located at the downstream bridge opening during the stream walk. The channel is unstable in this area and the headcut is likely to move upstream during high flows.

The bridge is 72% of the bankfull channel width in the area (22 feet) with limited vertical clearance. The bridge constricts flow and does not fit the stream channel. Large wood clogged the bridge opening during the July 2023 flood. The existing opening does not provide space for debris to pass under the road. It has been reported that sediment has deposited in the channel around and under the bridge limiting its capacity. The bridge should be replaced with an appropriately sized structure to meet Vermont Stream Alteration Standards (VTANR, 2014) and Vermont River Management Standards (Schiff et al., 2014) – structure width = 100% to 120% bankfull channel width.

Figure 11: Main Street Bridge viewed from Upstream

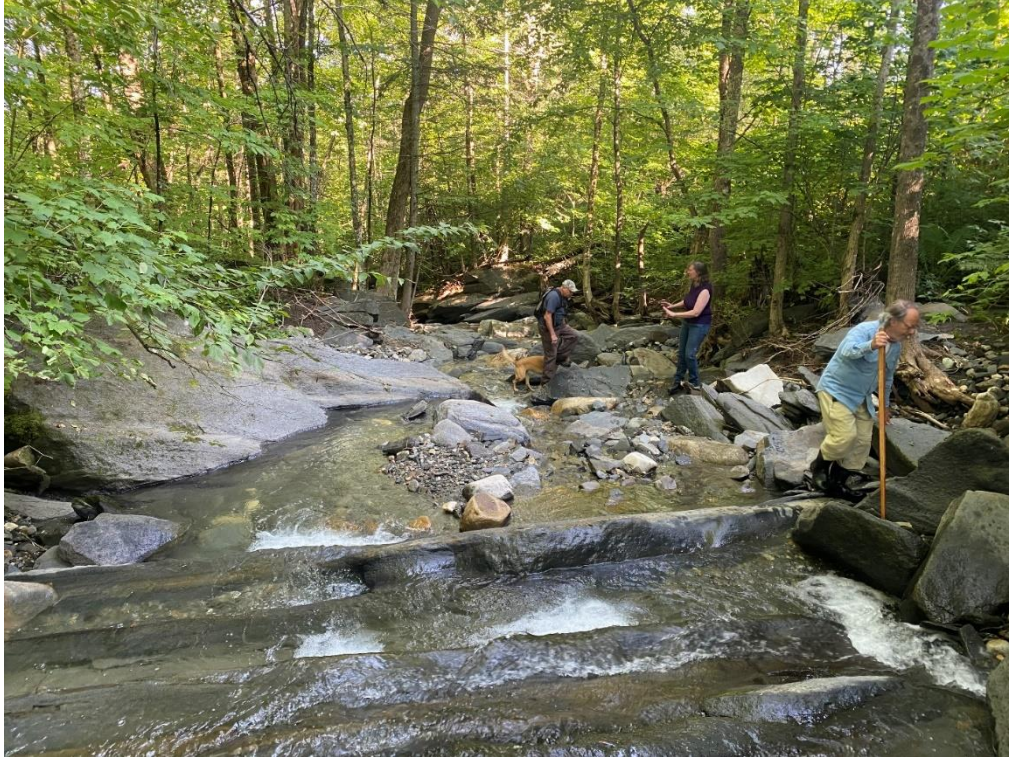
The Southern Tributary contains bedrock vanes spanning the channel just upstream of the village (Figure 12). The channel is steep with an 8.6% slope and contains small pools, bedrock drops, boulders and cobbles. The bankfull channel width ranges between 18.5 and 24 feet (Table 2). The channel width tends to be narrower in bedrock areas and wider where sediment accumulation has taken place.

**Figure 12: Southern Tributary Bedrock Controls**

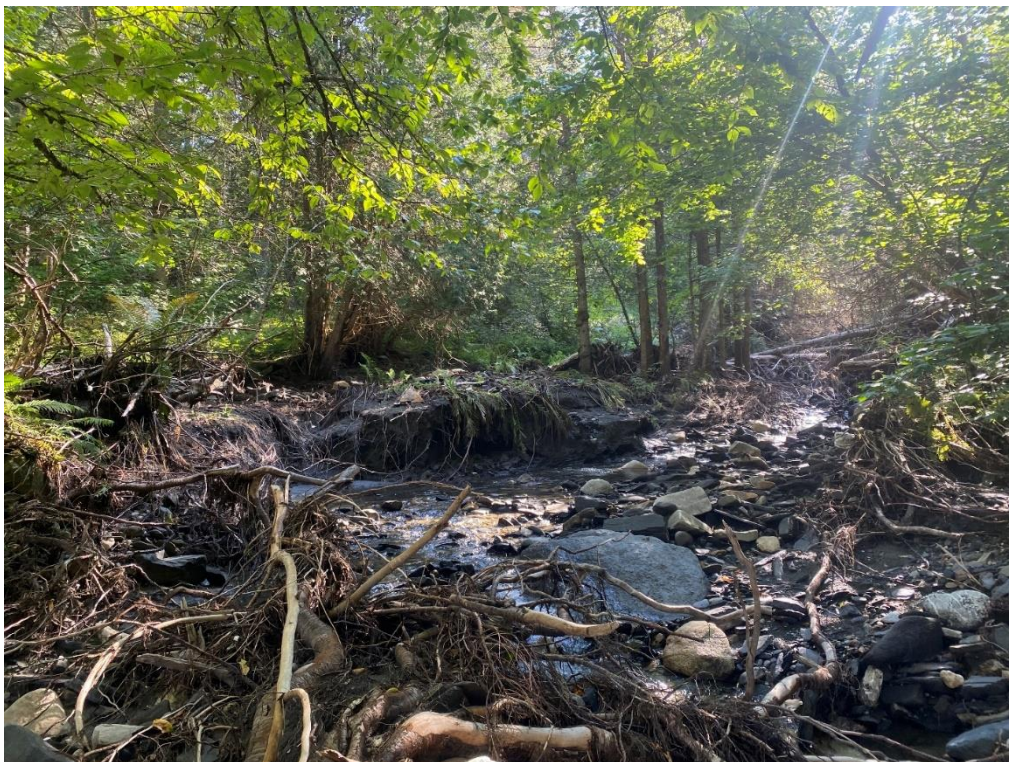
**Figure 14: Sediment and Large Wood Accumulated Upstream of Damaged VAST Bridge**

Upstream on the Southern Tributary it is recommended that the VAST bridge abutments be widened to fit the channel and the sediment and large wood be removed. This buildup of wood and large sediment pose a hazard to the downstream culverts and will continue until the VAST bridge is replaced.

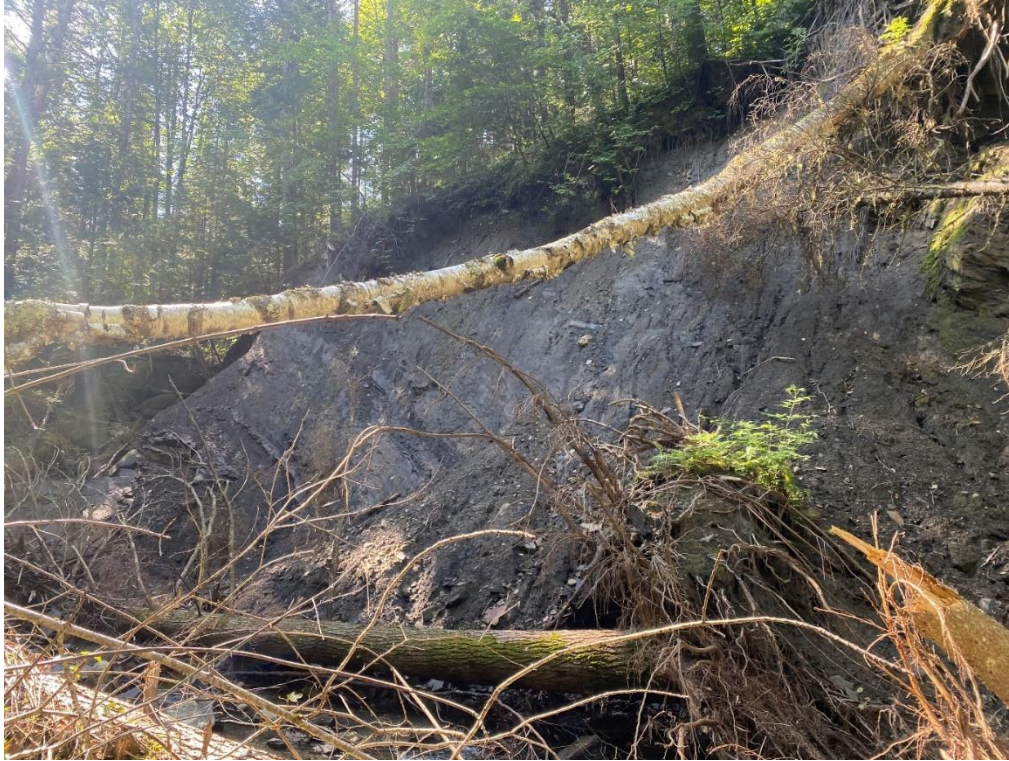
Moving upstream the Southern Tributary is comprised of many bedrock areas that are steep and narrow, coupled with wider areas of valley wall mass wasting where glacial till has eroded (Figure 15). These large erosion faces input sediment and large wood into the channel during flooding. Some of this material is temporarily stored in the channel by large wood jams that will periodically release and form during flooding (Figure 16). These stepped jams and storage areas are important to reduce downstream flood risk.

**Figure 15: Mass Wasting on the Southern Tributary**

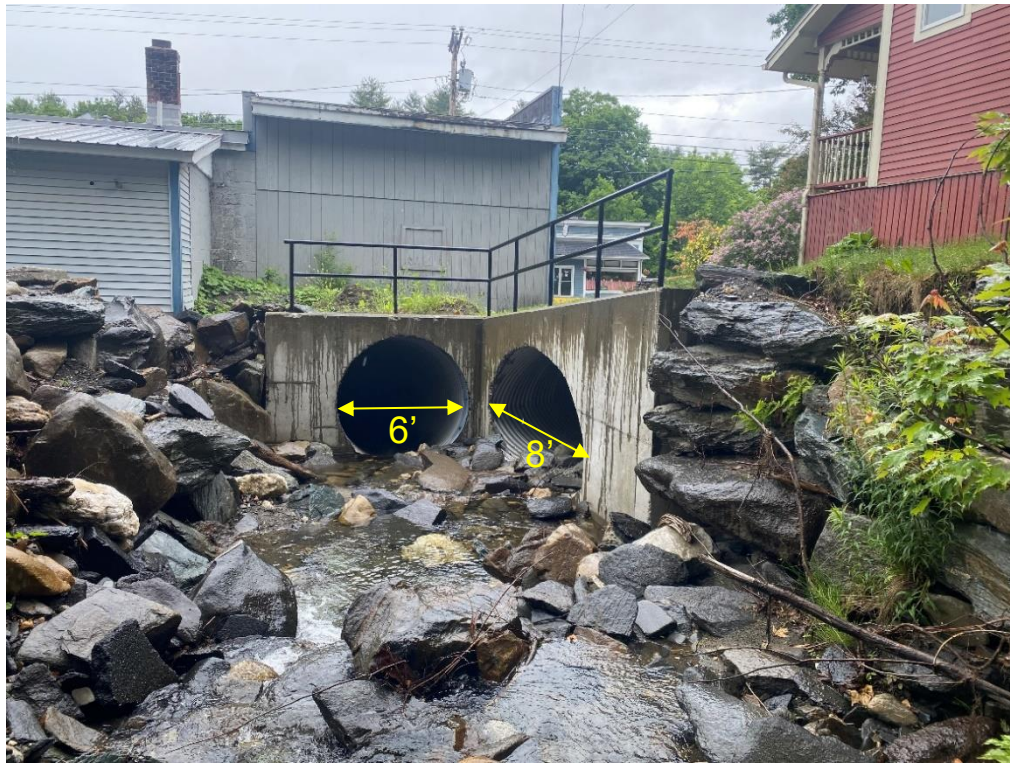
The two culverts combined provide a total flow width of 14 feet; however, the severe skew of the right culvert reduces the effective hydraulic opening. The culverts are between 50% and 70% of the bankfull channel width, and thus are not likely to pass flood waters and debris. Past flooding illustrates that in this severely constricted setting, just a few pieces of wood or several boulders quickly clog the culvert openings.

**Figure 17: Main Street Culverts viewed from Upstream**

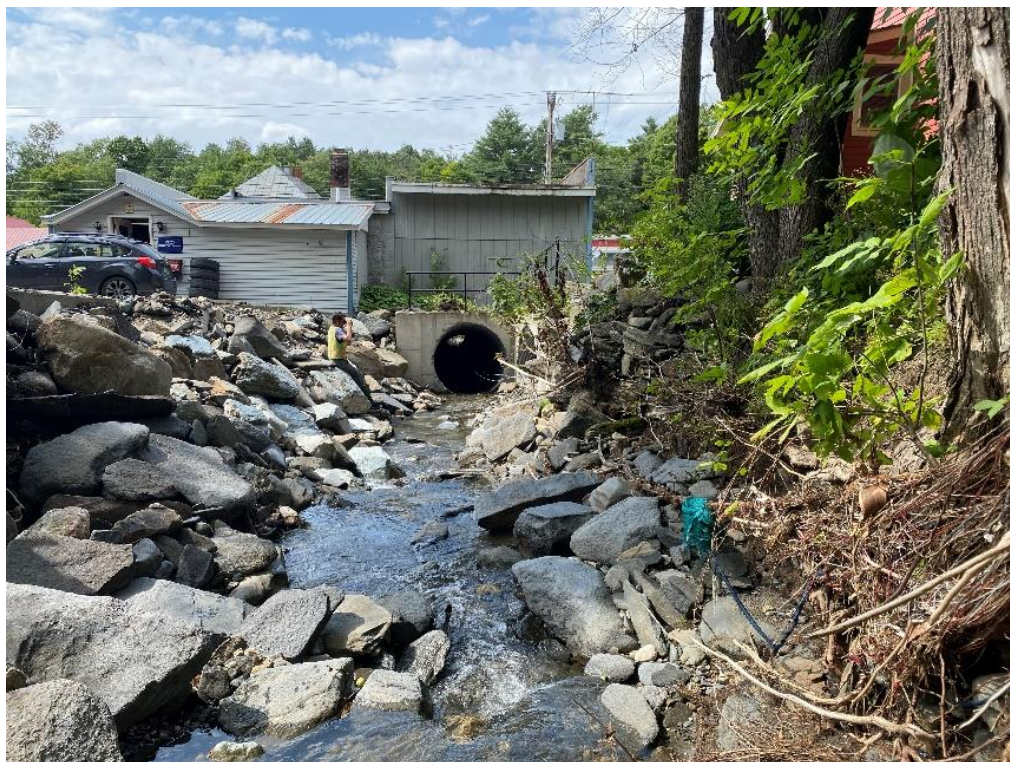
**Figure 18: Narrowed Channel Upstream of the Main Street Culverts**

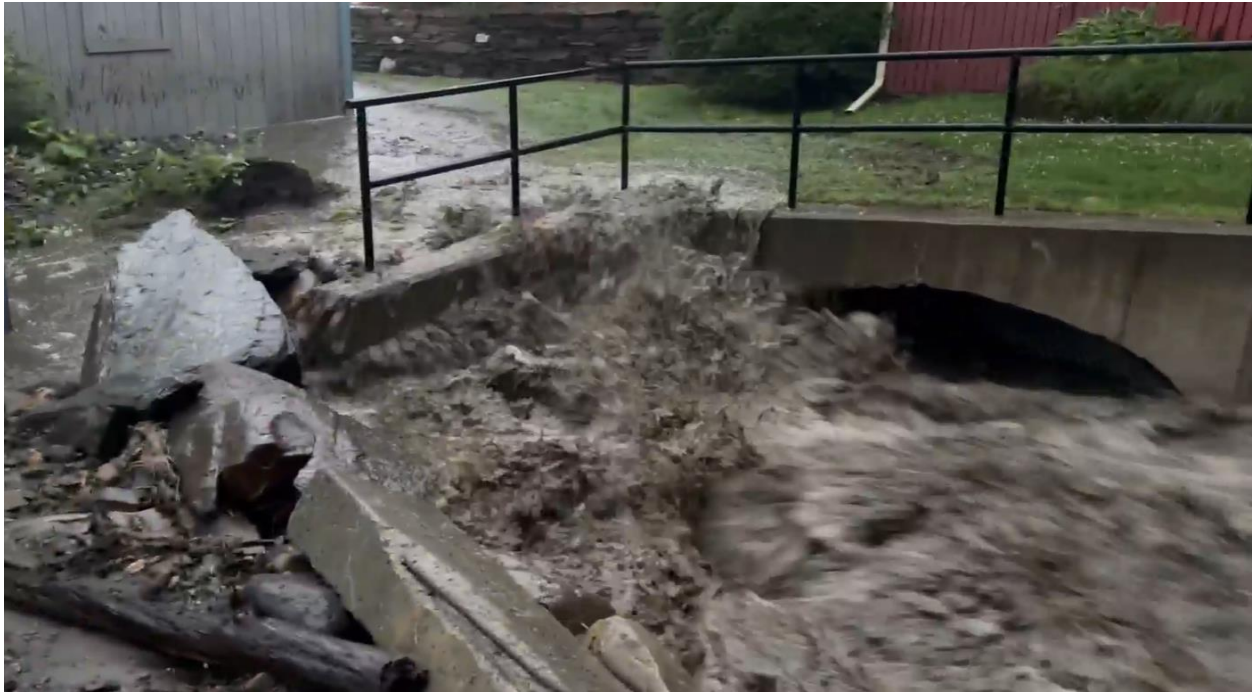
Photos and videos of the Southern Tributary culverts show that water was filling up the left culvert and just overtopping to flow around the garage and onto Main Street (Figure 21). The top of the left culvert is at elevation 1059.2 ft NAVD88 and the modeled peak flood water surface elevation is at EL 1059.3 ft. The plan view of the modeled flood velocity shows a flow pattern that matched the photo around the Cabot Garage (Figure 22).

**Figure 21: Flood waters overtopping culverts**

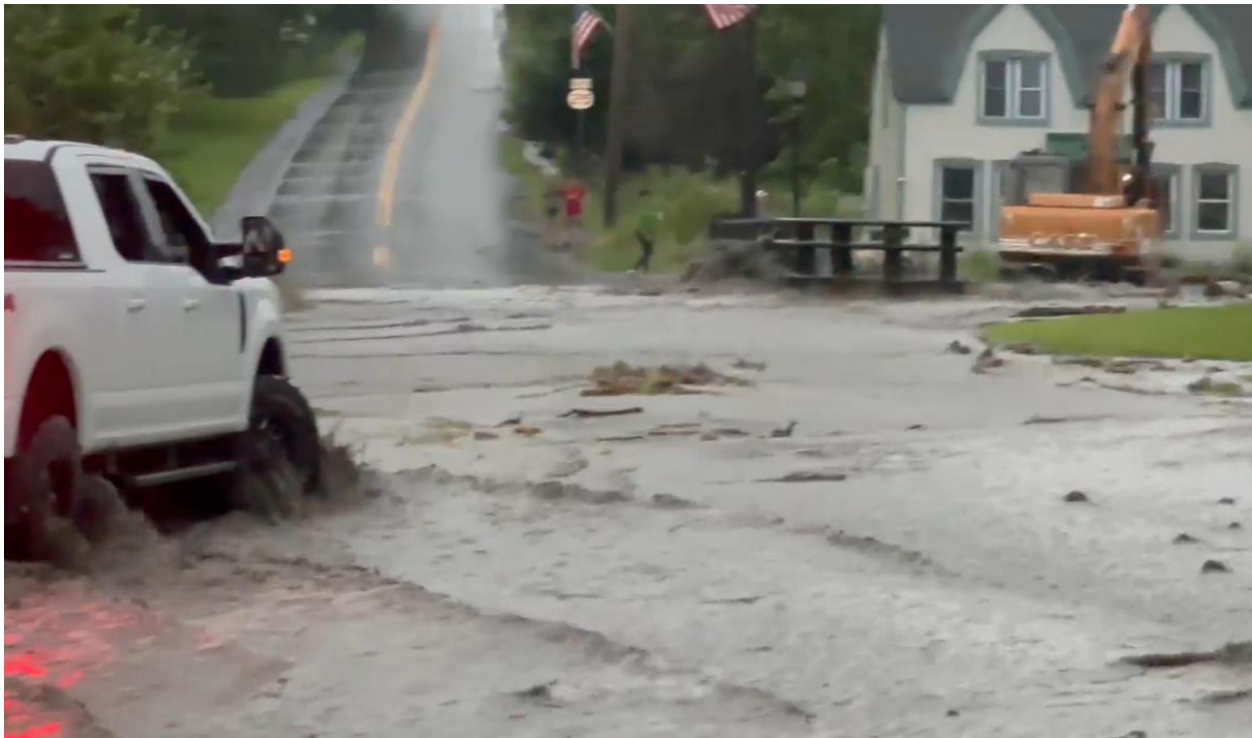
Images of the Northern Tributary overtopping the bridge under Main Street compare well to the 100-year flood modeling results. The bridge overtopped and flow travelled down Main Street (Figure 25). Modeling results found that the left side of the bridge is overtopped by approximately 1 foot during the 100-year flood (Figure 26). These validation results indicate that the accuracy of the model is appropriate for evaluation of alternatives to understand relative changes to flood patterns associated with various flood mitigation options.

**Figure 25: Northern Tributary flood waters overtopping the Main Street Bridge and flowing down Main Street**
