FROM: Milone & MacBroom, Inc.

DRAFT DATE: July 26, 2016

RE: Dam Removal Feasibility Assessment

Clark Saw Mill Dam – Cabot, Vermont

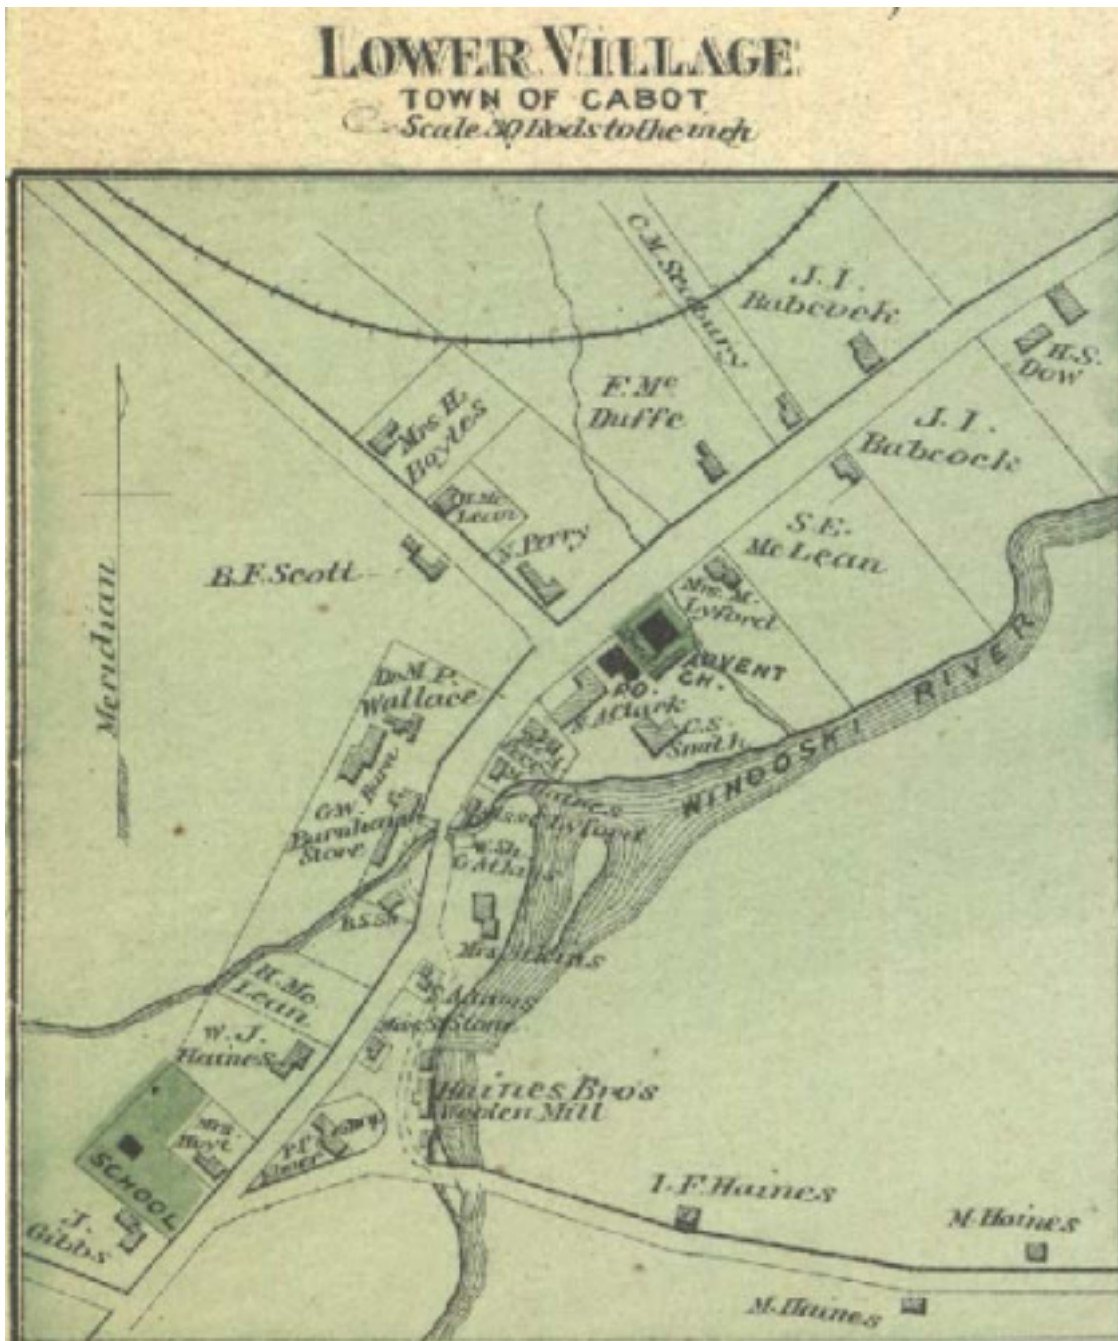
**Figure 4: Historic Map of Lower Village, Town of Cabot
(Map from the 1873 Beers Atlas)**

The historical review suggests that a larger pond, and possibly a second dam, existed at the project site. The *Beers Atlas* (Beers, 1873) (Figure 4) shows a larger impoundment upstream of the dam and an island. This area appears to now be filled with sediment and vegetation and to contain a wetland. The river channel bends around this area during low and normal flow.

The river channel could reoccupy the low wetland area on the river left side (facing downstream) of the channel that appears to have been river channel in the past (see Figure 4). Historical incision limits the likelihood of that happening following dam removal, yet this channel realignment could take place following a large flood, ice jam, or debris jam. This channel alignment could push the river toward river right where back yards are located that could lead to some loss of land along the existing channel. A sewer line exists in this area that could be exposed if erosion takes place in the area.
