Cabot Flood Study

Cabot, Vermont

SLR International Corporation

October 30, 2024

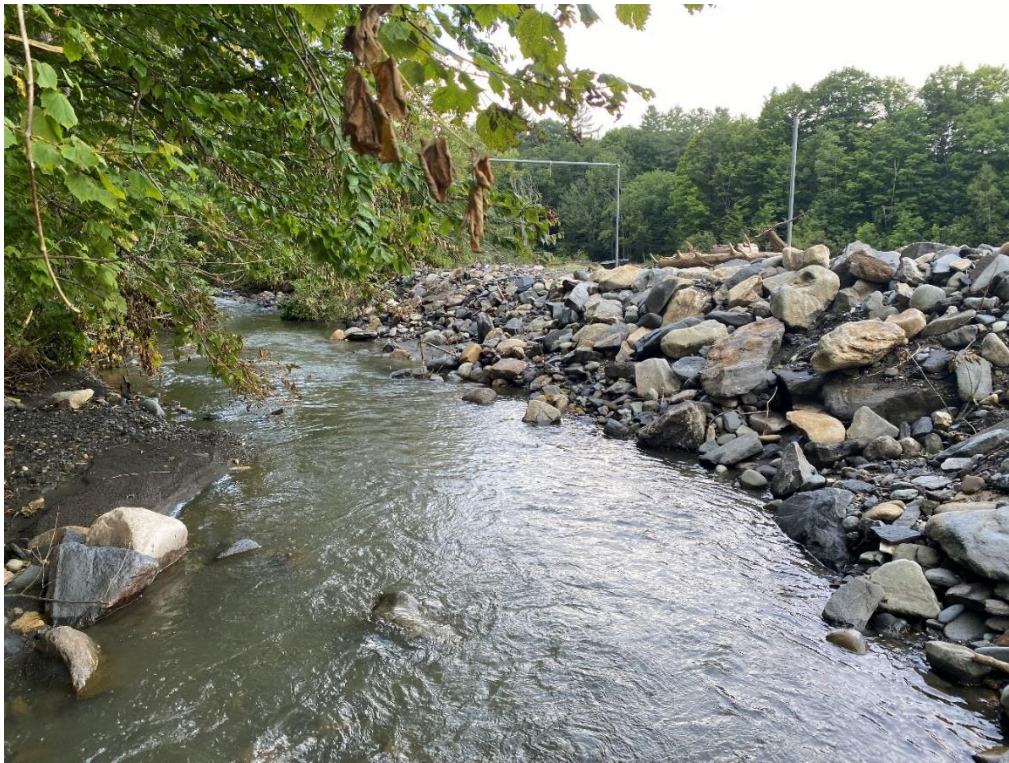
Figure 5: Northern Tributary along the Recreation Fields

The Northern Tributary consists of a flatter 2.6% slope riffle-pool channel from the Winooski River confluence to the Main Street Bridge. The channel appears to have been recently dredged and some berming has taken place along the recreation fields (Figure 5). The channel bed material in this area is typically dominated by cobble, boulder and gravel; yet in the dredged area the channel is smoother and dominated by gravel. Gravel is building up in the post-dredge channel, the gravel is soft under foot, and the channel is less stable with signs of bank erosion.

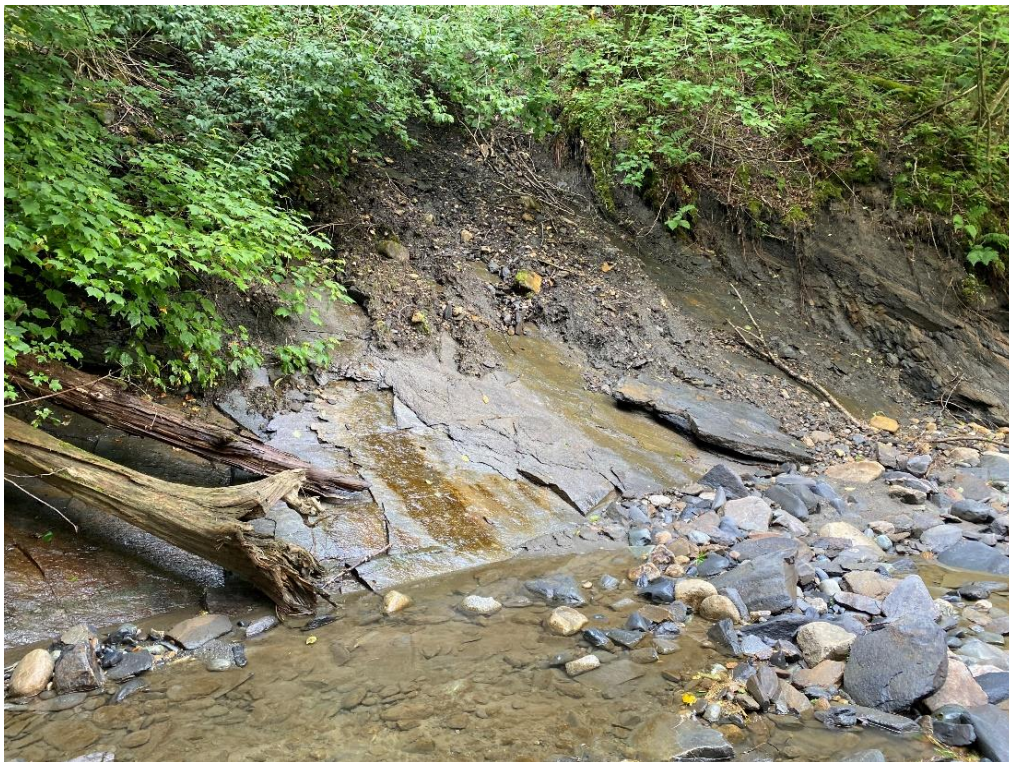
Figure 8: Steep Bedrock and Till Northern Tributary

Moving upstream the channel enters the forest, narrows, and steepens to 4.1% (Figure 7). The bankfull channel width decreases and is in the range of 16.5 to 21.0 feet (Table 1). The channel often contains bedrock on the bed and banks, as well as dense glacial till (Figure 8). The bedrock narrows store large sediment between floods. Periodic land slides exist where the base of the dense till was eroded and the overlying tall bank collapsed (Figure 9). The mass failures are a source of sediment and large wood into the channel, some of which makes its way to the Main Street Bridge in the village and some of which is stored in the channel behind intermittent debris jams and on small flood shelves along the channel (Figure 10). These features are important to regulate the amount of material headed to the village during a single flood event.

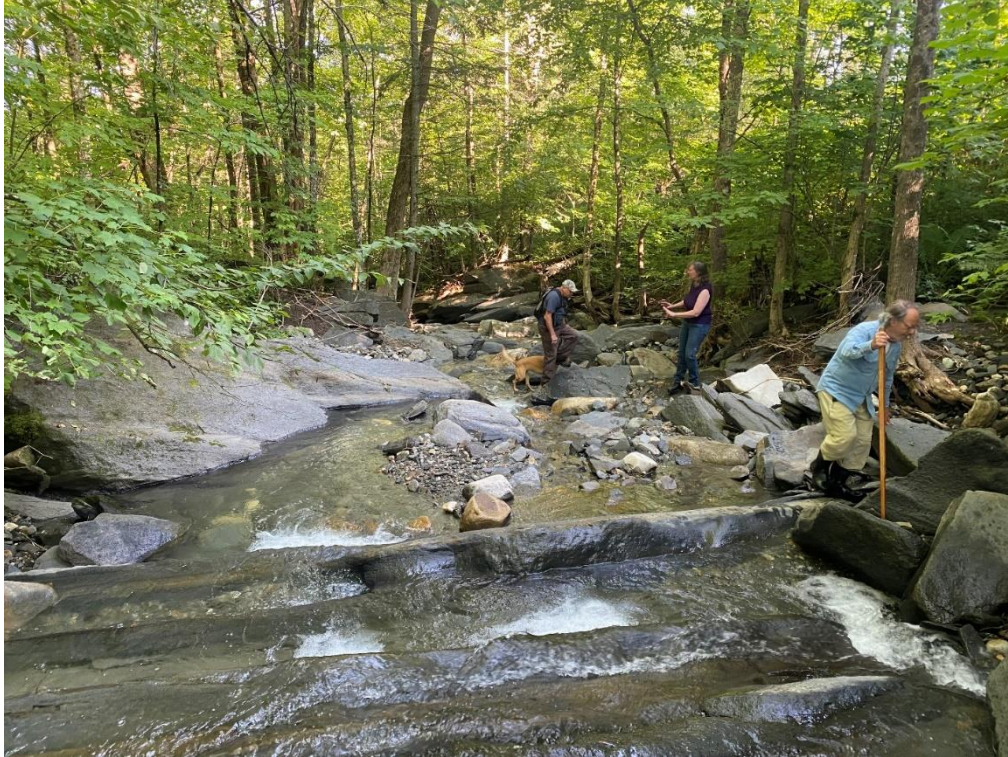
Figure 12: Southern Tributary Bedrock Controls

The Southern Tributary contains bedrock vanes spanning the channel just upstream of the village (Figure 12). The channel is steep with an 8.6% slope and contains small pools, bedrock drops, boulders and cobbles. The bankfull channel width ranges between 18.5 and 24 feet (Table 2). The channel width tends to be narrower in bedrock areas and wider where sediment accumulation has taken place.

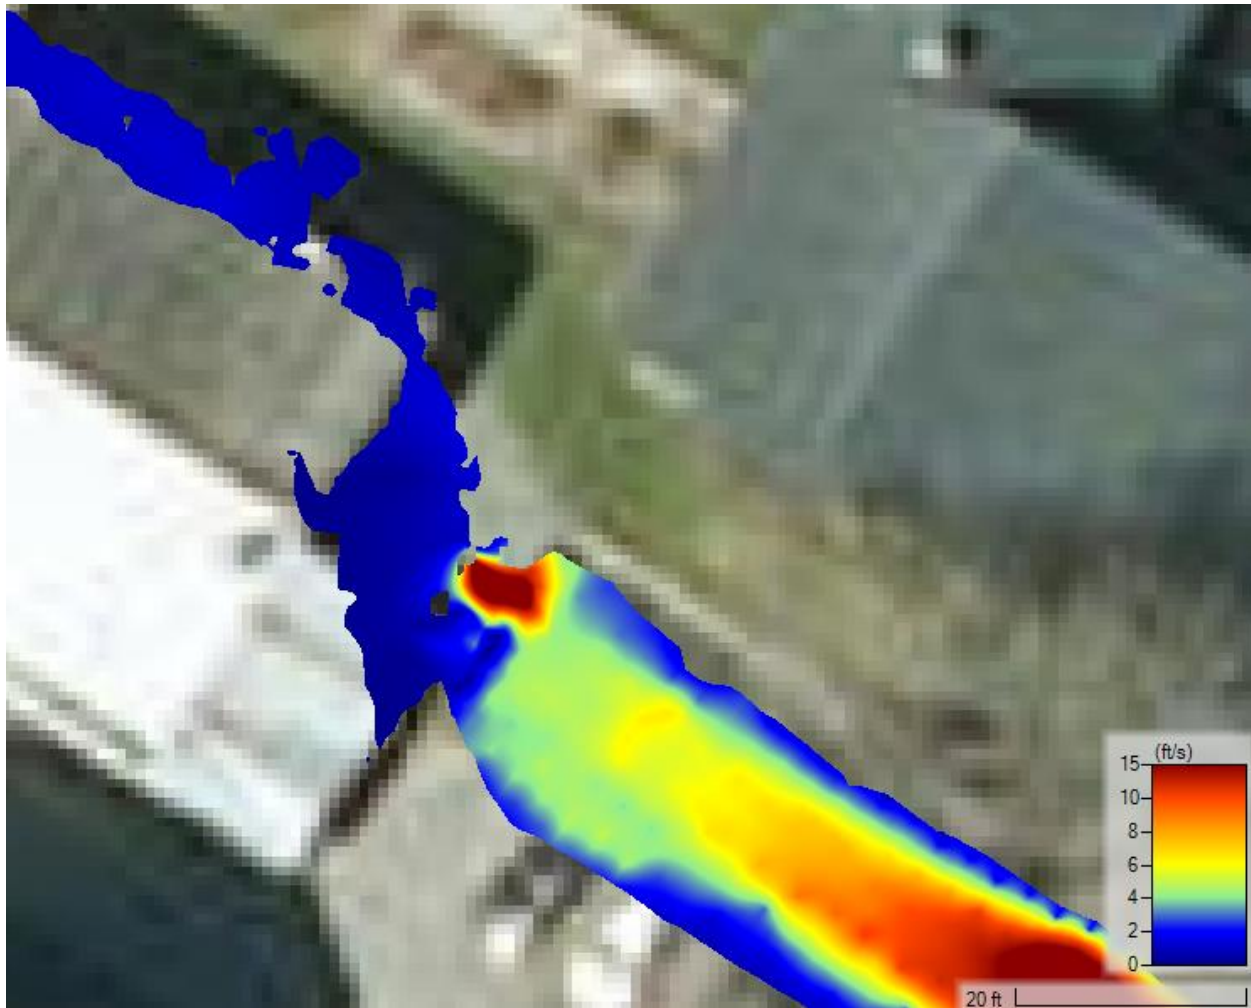
Figure 22: Modeled 100-year flood velocities as the flow overtops the culverts and flows around the garage

Photos and videos of the Southern Tributary culverts show that water was filling up the left culvert and just overtopping to flow around the garage and onto Main Street (Figure 21). The top of the left culvert is at elevation 1059.2 ft NAVD88 and the modeled peak flood water surface elevation is at EL 1059.3 ft. The plan view of the modeled flood velocity shows a flow pattern that matched the photo around the Cabot Garage (Figure 22).

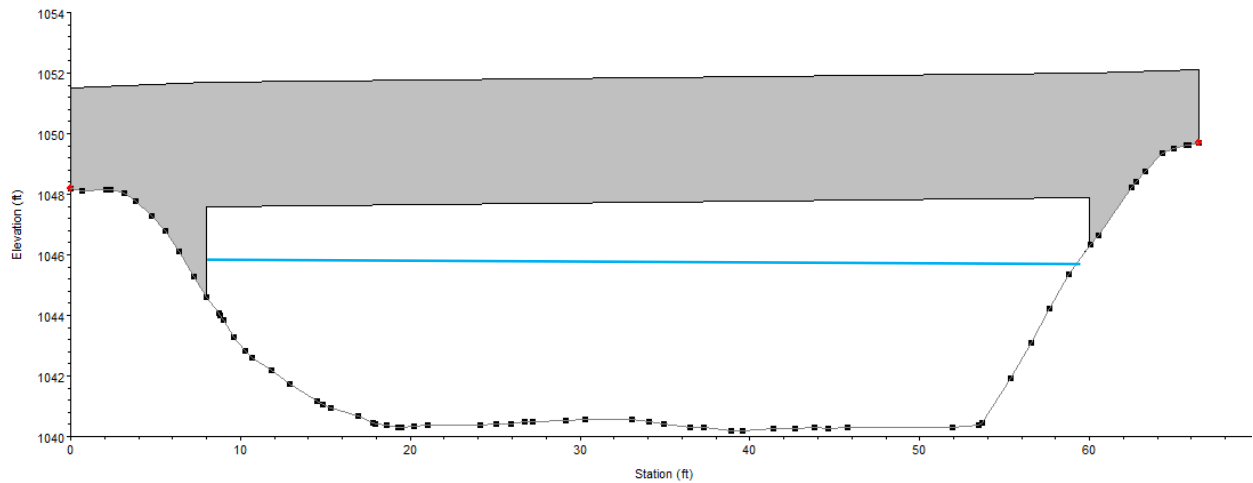
Figure 24: Modeled 100-year flow at the VAST bridge

Model results on the mainstem of the Winooski River were compared to images of the flood waters passing under the VAST bridge. The photo shows the flood water approximately 1.5 to 2 feet below the 3-foot deep steel beams (Figure 23). Model results found that the water surface under the bridge is approximately 1.8 feet below the steel beams for the 100-year flood (Figure 24).

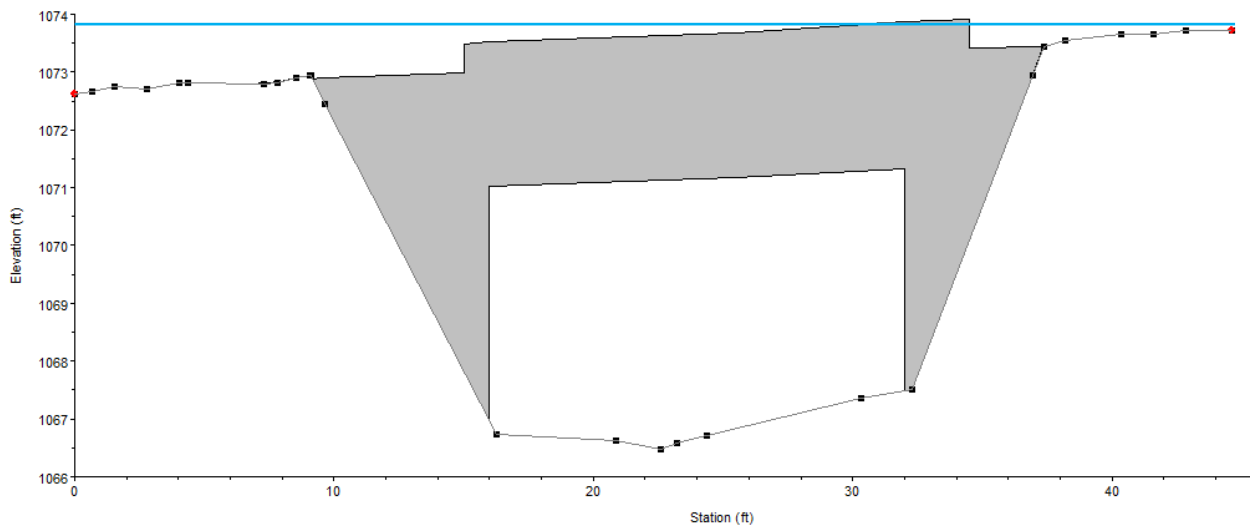
Figure 26: Modeled 100-year flow at the Main Street Bridge

Images of the Northern Tributary overtopping the bridge under Main Street compare well to the 100-year flood modeling results. The bridge overtopped and flow travelled down Main Street (Figure 25). Modeling results found that the left side of the bridge is overtopped by approximately 1 foot during the 100-year flood (Figure 26). These validation results indicate that the accuracy of the model is appropriate for evaluation of alternatives to understand relative changes to flood patterns associated with various flood mitigation options.

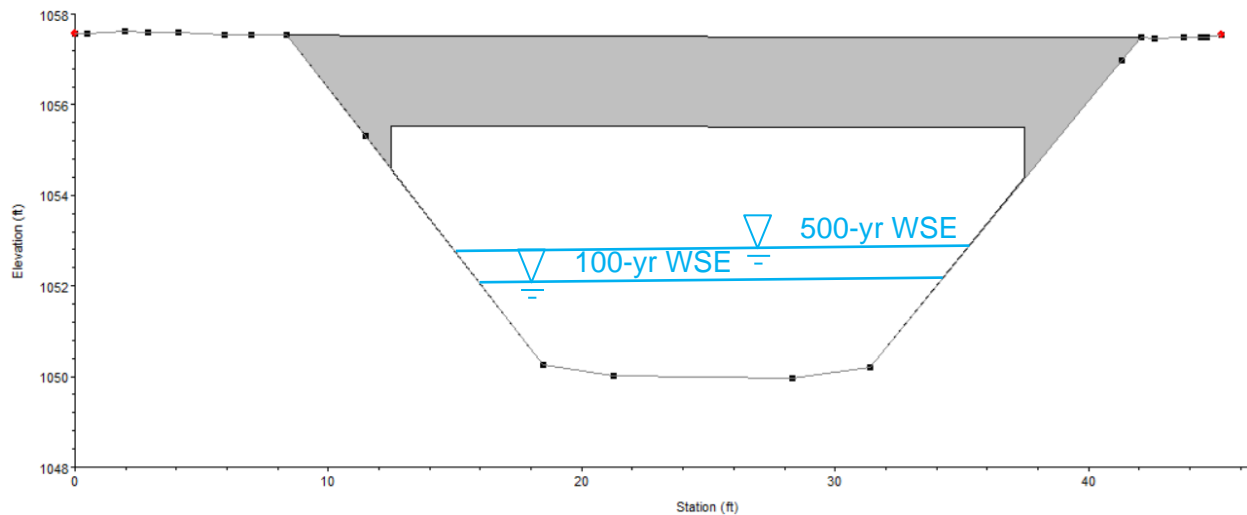
Figure 28: Model results for 30 foot span bridge

The modeled bridge passes all modeled flows including the 500-year flood. The 500-year flood depth is approximately 2.8 feet under the bridge opening leaving 2.7 feet of freeboard to accommodate debris flow (Figure 28). A small amount of flooding occurs during the 500-year flood at the upstream end of the parking lot where the streambank is low, however flood depth is less than 0.5 feet. This alternative is recommended as the bridge is able to pass large floods and provides space for debris flow to pass through its opening.

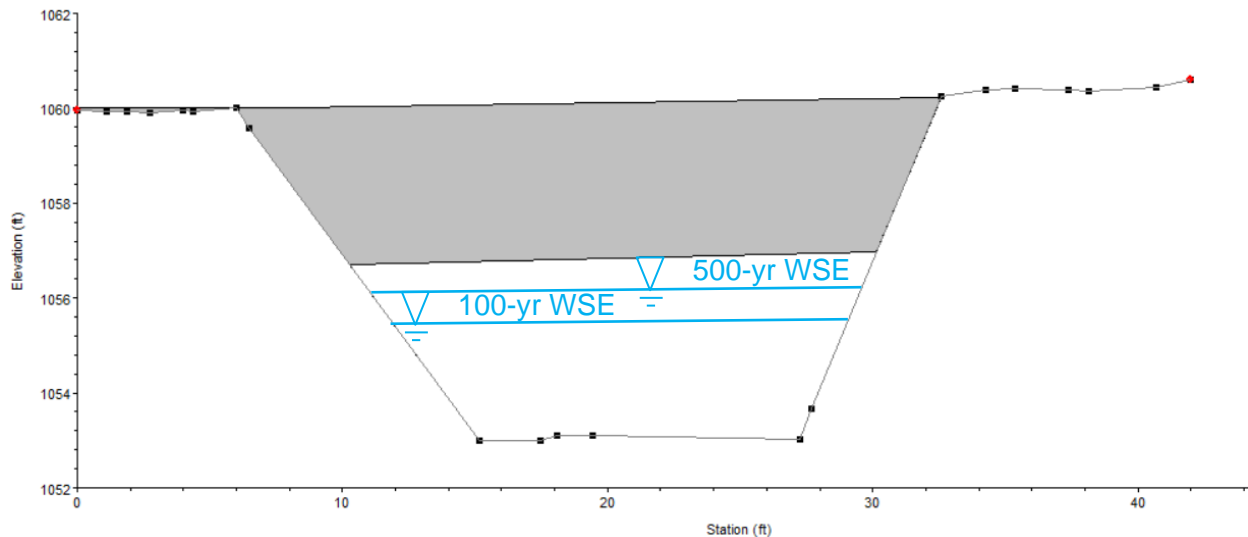
Figure 29: Model results for 30 foot span bridge

This long bridge structure passes the modeled flows including the 500-year flood. The 500-year flood has a depth of 3.1 feet at the upstream bridge opening leaving about 0.7 feet of freeboard to the low chord elevation (Figure 29). This design does not allow for adequate space for debris flow to pass through the bridge.

Construction of this structure would require temporary removal of the Garage building and replacement after the bridge is completed. Costs and complication of construction would be much higher than Alternative 3. Benefits would be less as the structure provides less space for debris flow than the shorter bridge in Alternative 3. For these reasons this alternative is not recommended.

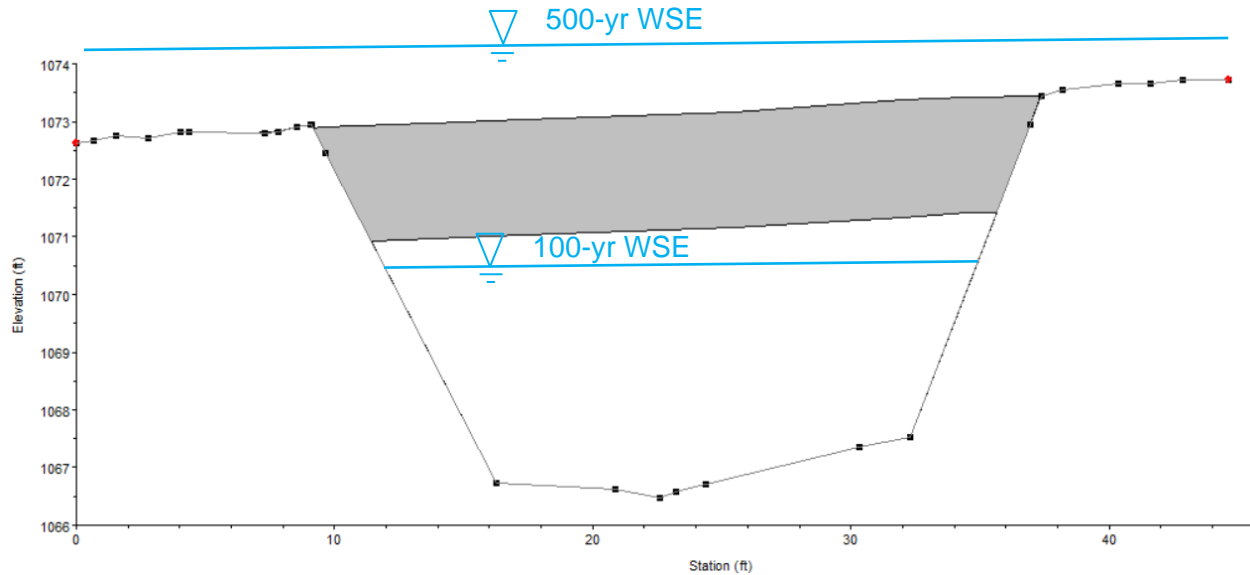
Figure 30: Model results for 30 foot span bridge

The width of the existing bridge is much narrower than the measured bankfull widths of the channel. A 30 foot span bridge was evaluated as it could be built to replace the existing bridge in the existing space and layout. The wider span bridge can pass the 100-year flood, but the 500-year flood overtops the road (Figure 30). With less than one foot of freeboard between the 100-year water surface and the low chord, there is high risk of debris clogging the opening and causing flooding during the 100-year flood. Based on this result a structure with the existing deck elevation cannot provide the capacity to pass larger floods. This alternative is not recommended.

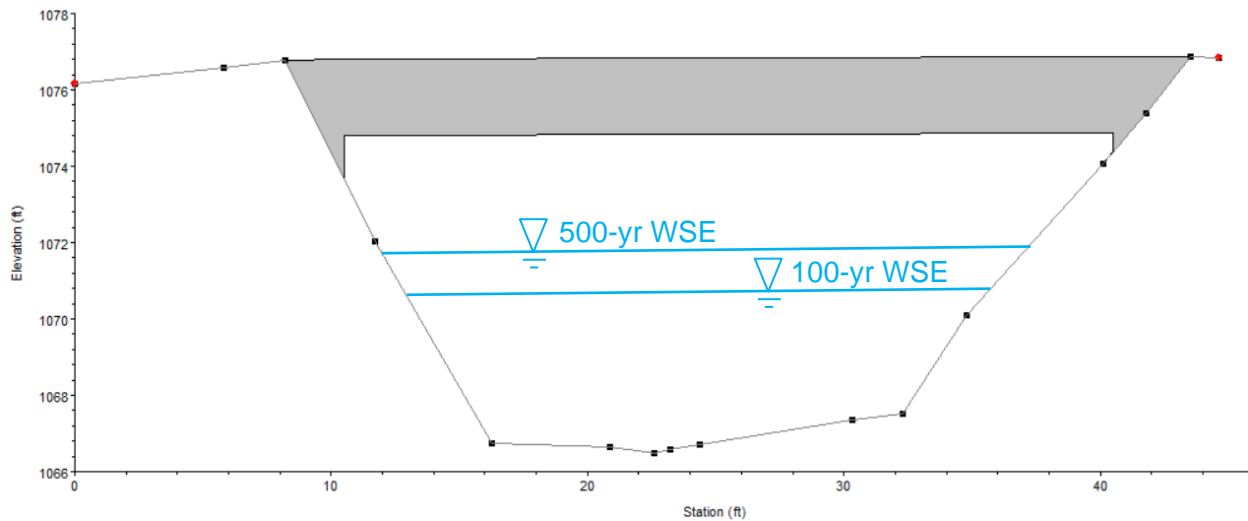
Figure 31: Model results for elevated 30 foot span bridge

The elevated 30 foot span bridge passes all modeled flows up to the 500-year flow (Figure 31). The elevated bridge deck leaves additional space for debris flow. The 500-year flood depth is approximately 6 feet that leaves about 2.5 feet of freeboard for debris flow. This meets the suggested 20% of bridge opening for debris flow decreasing the risk of clogging from large wood (Furniss et al., 1998).

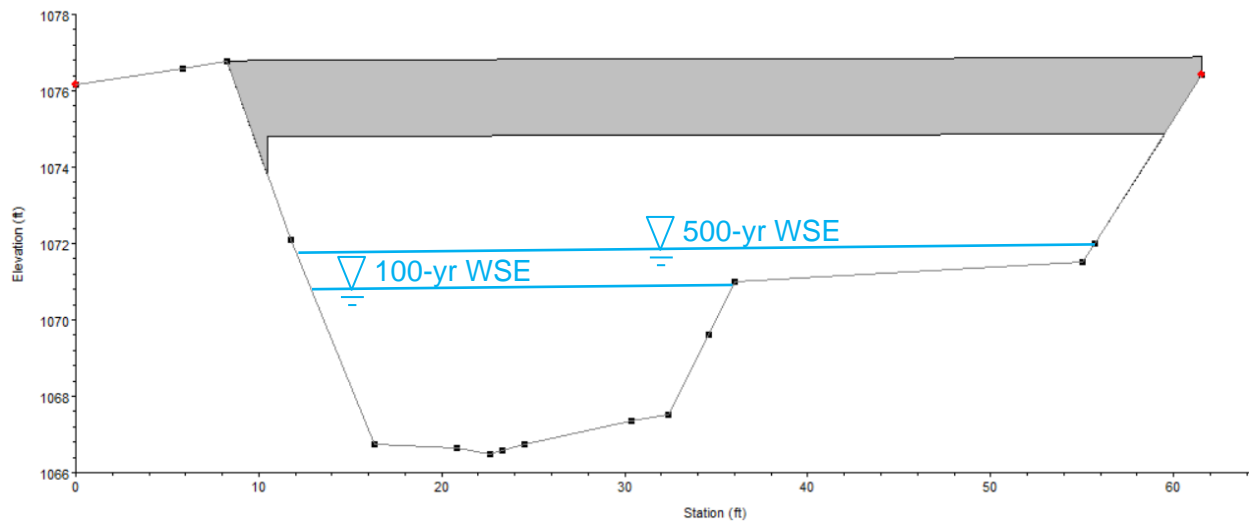
Figure 32: Model results for elevated 50 foot span bridge

The 100- and 500-year water surface elevations are similar to Alternative 7 providing the same amount of freeboard for debris flow (Figure 32). However the area for additional flow and debris passage is larger with a flood bench. In the event of debris clogging, the wider span provides more capacity for passage of flood flow and other debris. This wider bridge and flood bench is a more resilient alternative.

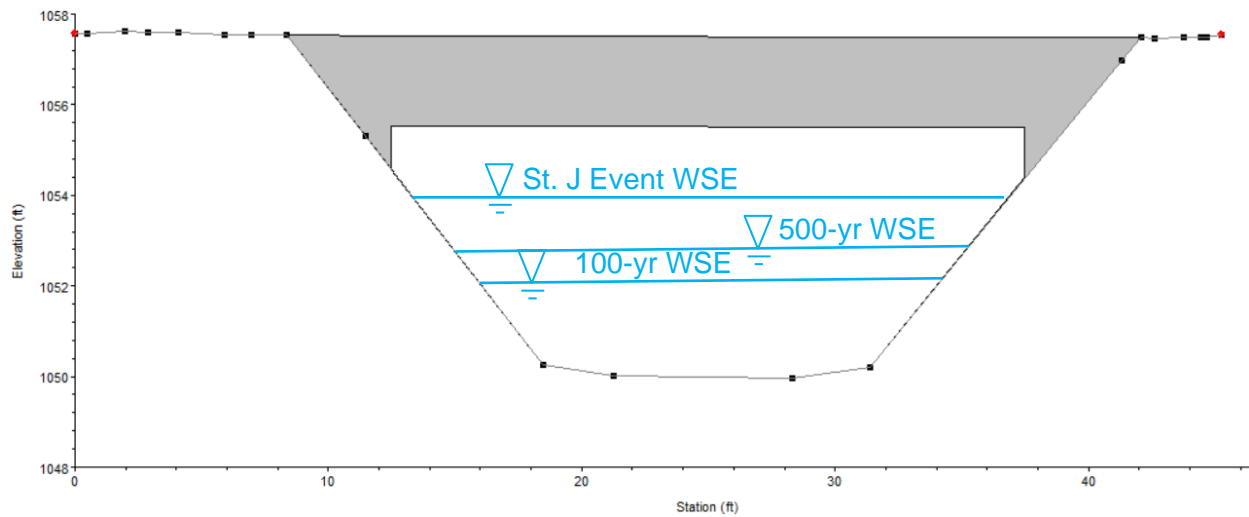
Figure 33: Model results for Southern Tributary Alternative 3 – 30 foot span bridge

The hydraulic model was run for the existing conditions and the preferred alternatives for each tributary – Alternatives 3 and 8. The proposed bridge on each tributary passes the modeled flood flow without overtopping (Figure 33 and Figure 34). . Flood inundation of adjacent
