# Cabot Flood Study

## Cabot, Vermont

**SLR International Corporation**

October 30, 2024

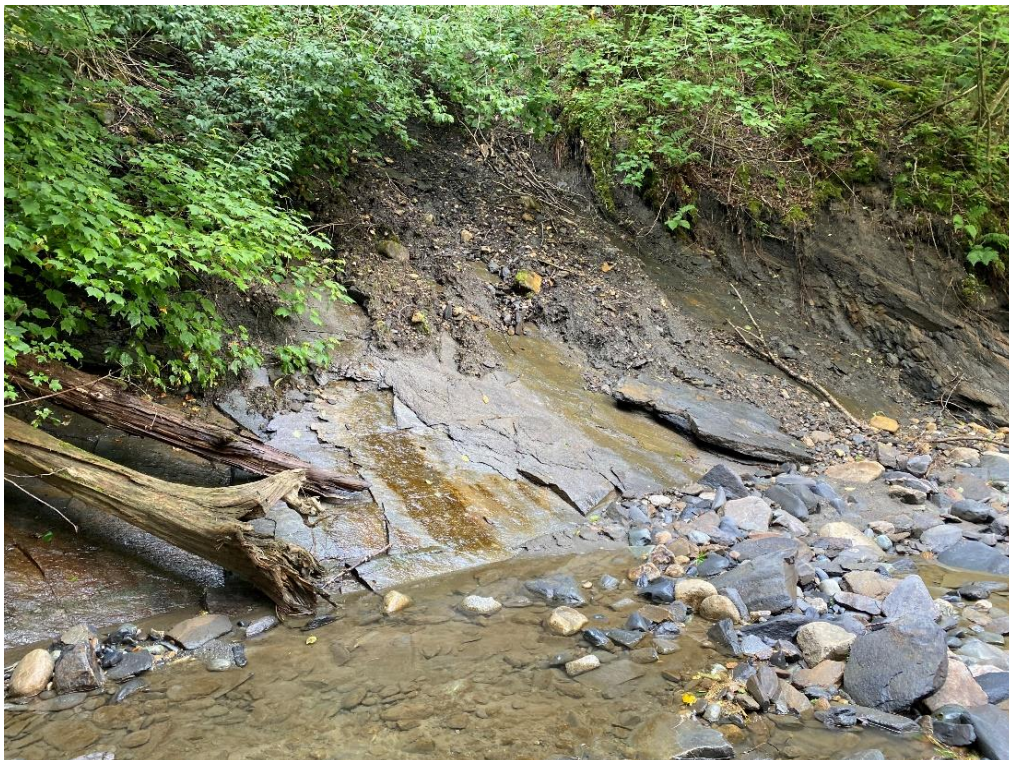
**Figure 8: Steep Bedrock and Till Northern Tributary**

Moving upstream the channel enters the forest, narrows, and steepens to 4.1% (Figure 7). The bankfull channel width decreases and is in the range of 16.5 to 21.0 feet (Table 1). The channel often contains bedrock on the bed and banks, as well as dense glacial till (Figure 8). The bedrock narrows store large sediment between floods. Periodic land slides exist where the base of the dense till was eroded and the overlying tall bank collapsed (Figure 9). The mass failures are a source of sediment and large wood into the channel, some of which makes its way to the Main Street Bridge in the village and some of which is stored in the channel behind intermittent debris jams and on small flood shelves along the channel (Figure 10). These features are important to regulate the amount of material headed to the village during a single flood event.

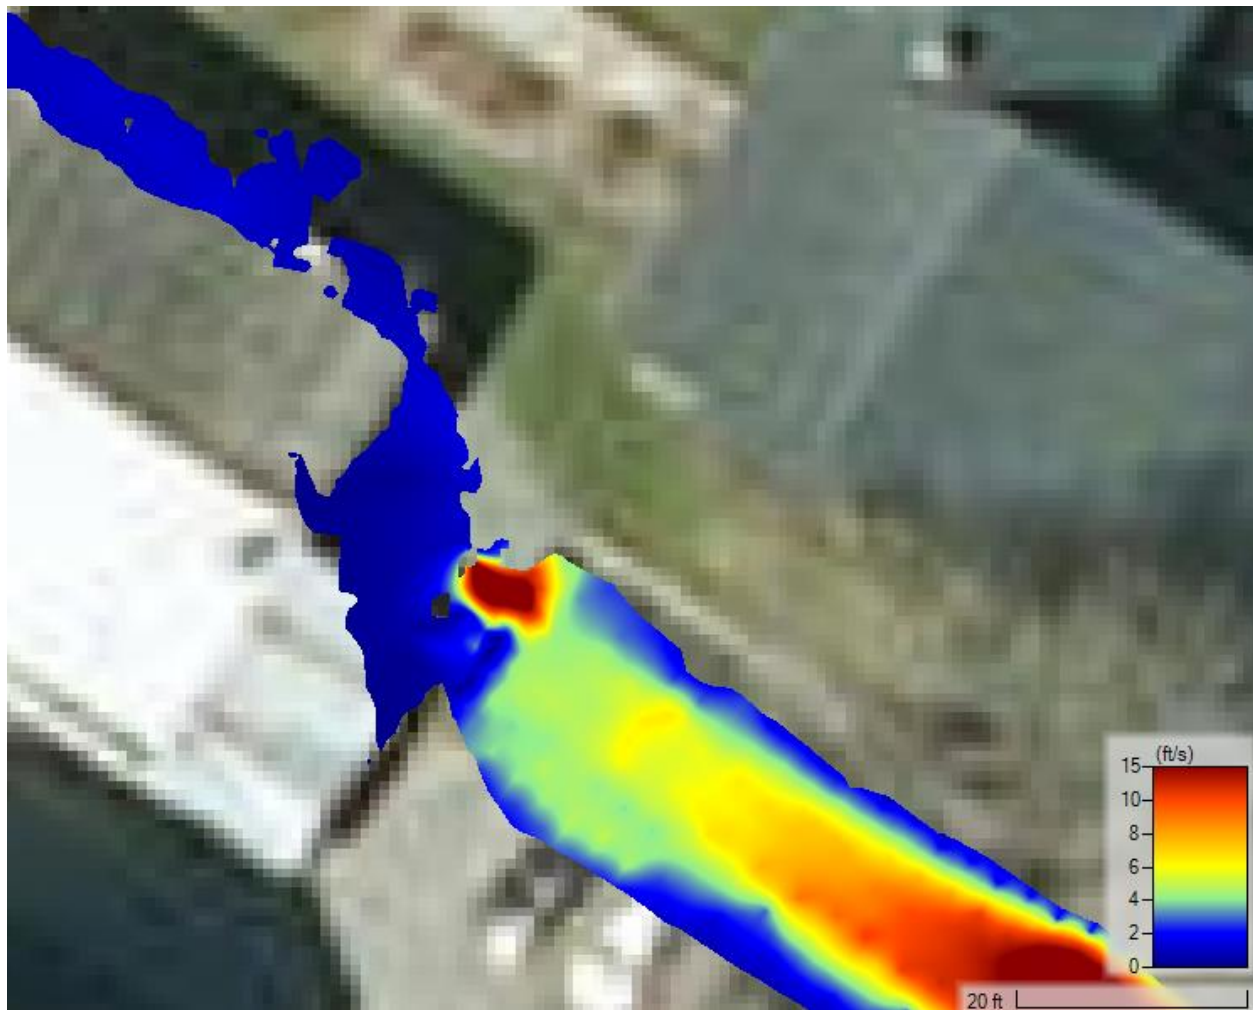
**Figure 22: Modeled 100-year flood velocities as the flow overtops the culverts and flows around the garage**

Photos and videos of the Southern Tributary culverts show that water was filling up the left culvert and just overtopping to flow around the garage and onto Main Street (Figure 21). The top of the left culvert is at elevation 1059.2 ft NAVD88 and the modeled peak flood water surface elevation is at EL 1059.3 ft. The plan view of the modeled flood velocity shows a flow pattern that matched the photo around the Cabot Garage (Figure 22).

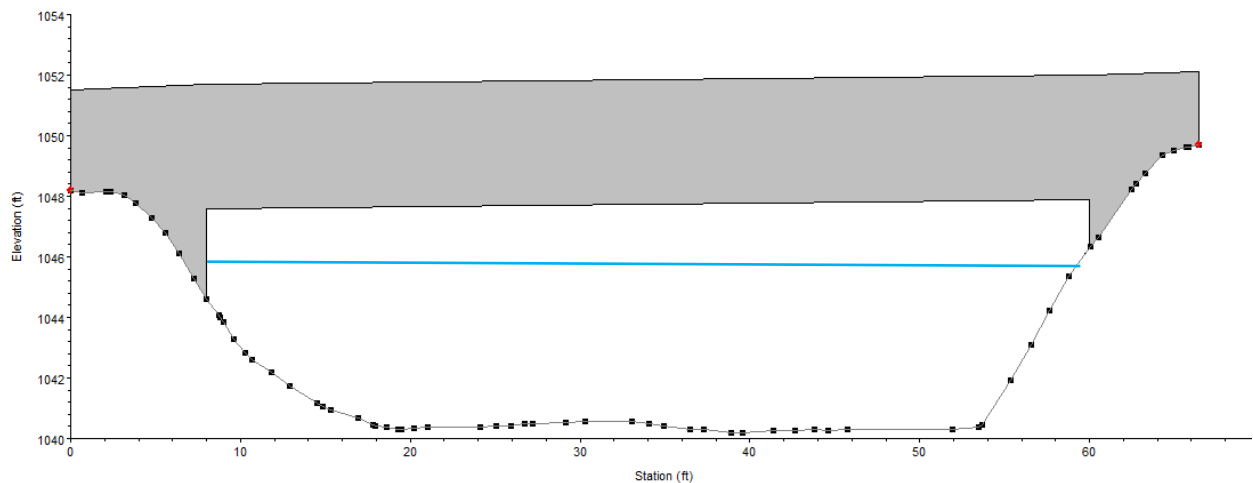
**Figure 24: Modeled 100-year flow at the VAST bridge**

Model results on the mainstem of the Winooski River were compared to images of the flood waters passing under the VAST bridge. The photo shows the flood water approximately 1.5 to 2 feet below the 3-foot deep steel beams (Figure 23). Model results found that the water surface under the bridge is approximately 1.8 feet below the steel beams for the 100-year flood (Figure 24).

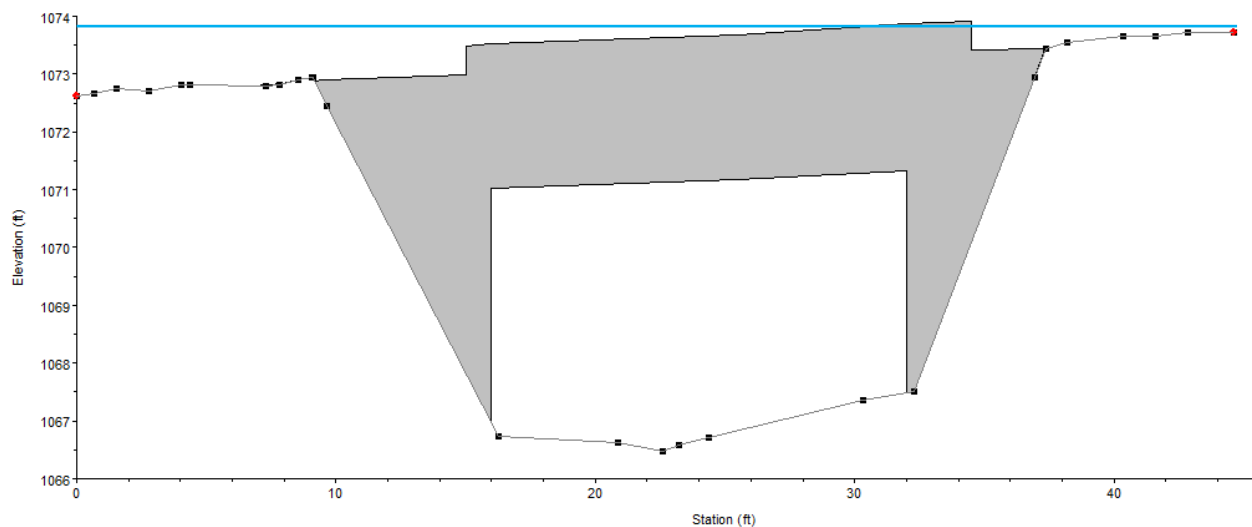
**Figure 26: Modeled 100-year flow at the Main Street Bridge**

Images of the Northern Tributary overtopping the bridge under Main Street compare well to the 100-year flood modeling results. The bridge overtopped and flow travelled down Main Street (Figure 25). Modeling results found that the left side of the bridge is overtopped by approximately 1 foot during the 100-year flood (Figure 26). These validation results indicate that the accuracy of the model is appropriate for evaluation of alternatives to understand relative changes to flood patterns associated with various flood mitigation options.

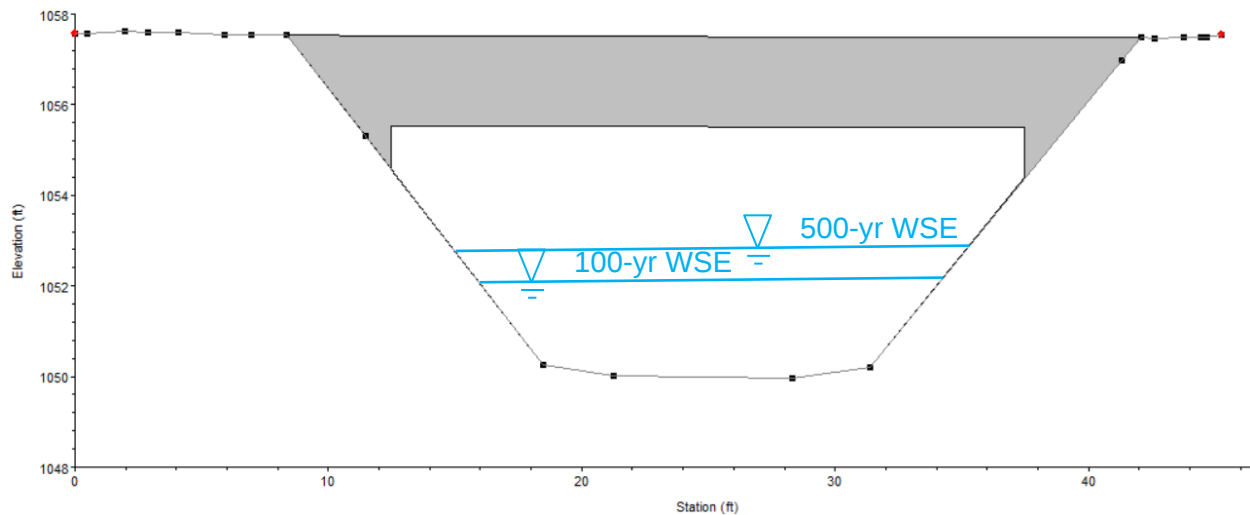
**Figure 28: Model results for 30 foot span bridge**

The modeled bridge passes all modeled flows including the 500-year flood. The 500-year flood depth is approximately 2.8 feet under the bridge opening leaving 2.7 feet of freeboard to accommodate debris flow (Figure 28). A small amount of flooding occurs during the 500-year flood at the upstream end of the parking lot where the streambank is low, however flood depth is less than 0.5 feet. This alternative is recommended as the bridge is able to pass large floods and provides space for debris flow to pass through its opening.

| ID | Location | Description |
|---|---|---|
| 3 | Southern Tributary Culverts | Remove Garage building and replace culverts with bridge |

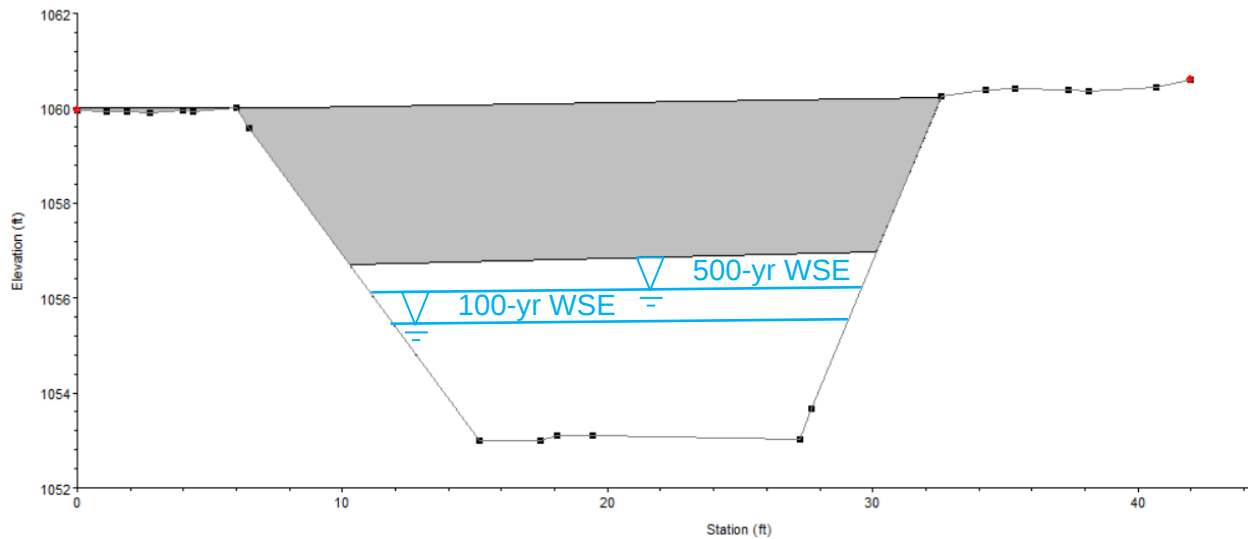
**Figure 29: Model results for 30 foot span bridge**

This long bridge structure passes the modeled flows including the 500-year flood. The 500-year flood has a depth of 3.1 feet at the upstream bridge opening leaving about 0.7 feet of freeboard to the low chord elevation (Figure 29). This design does not allow for adequate space for debris flow to pass through the bridge.

Construction of this structure would require temporary removal of the Garage building and replacement after the bridge is completed. Costs and complication of construction would be much higher than Alternative 3. Benefits would be less as the structure provides less space for debris flow than the shorter bridge in Alternative 3. For these reasons this alternative is not recommended.

| ID | Location | Description |
|---|---|---|
| 4 | Southern Tributary Culverts | Keep Garage building and replace culverts with bridge |

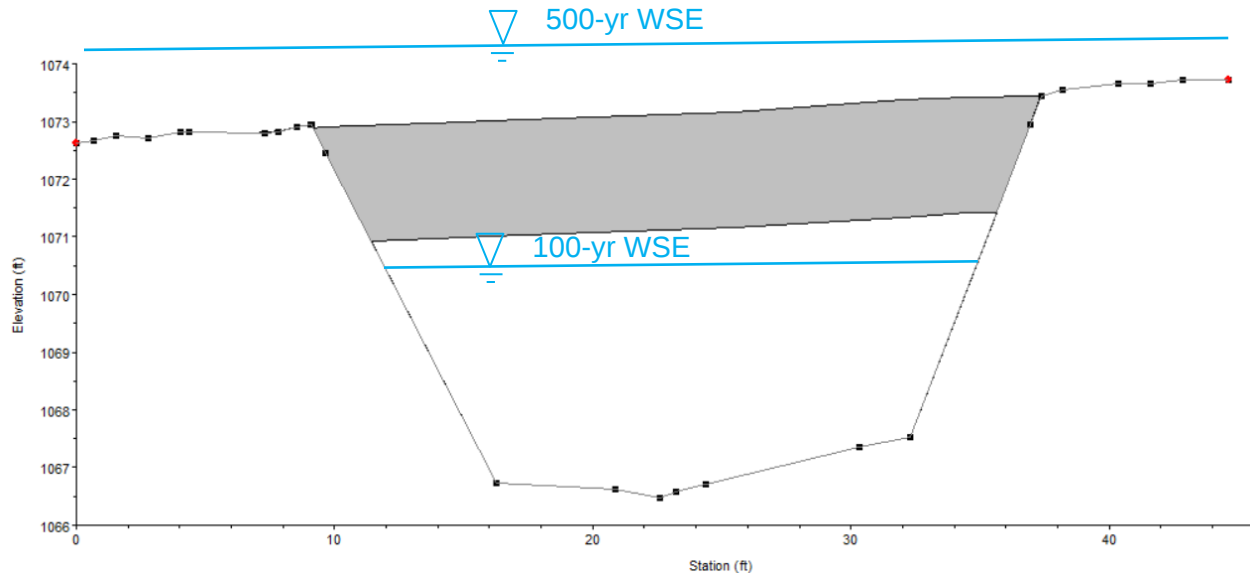
**Figure 30: Model results for 30 foot span bridge**

The width of the existing bridge is much narrower than the measured bankfull widths of the channel. A 30 foot span bridge was evaluated as it could be built to replace the existing bridge in the existing space and layout. The wider span bridge can pass the 100-year flood, but the 500-year flood overtops the road (Figure 30). With less than one foot of freeboard between the 100-year water surface and the low chord, there is high risk of debris clogging the opening and causing flooding during the 100-year flood. Based on this result a structure with the existing deck elevation cannot provide the capacity to pass larger floods. This alternative is not recommended.

| ID | Location | Description |
|---|---|---|
| 6 | Northern Tributary Bridge | Replace bridge with 30 foot span bridge |

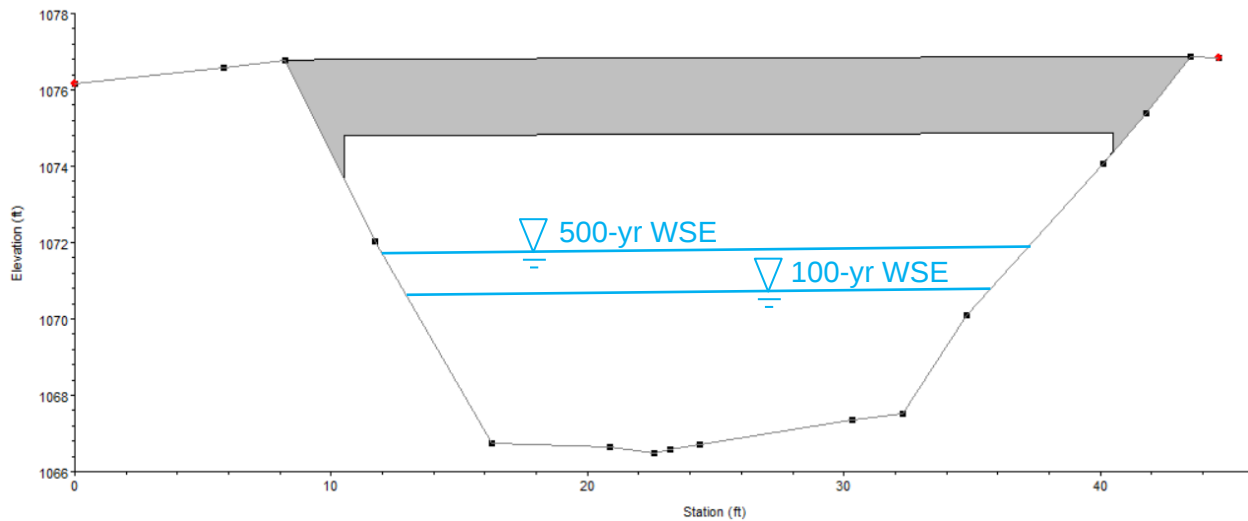
**Figure 31: Model results for elevated 30 foot span bridge**

The elevated 30 foot span bridge passes all modeled flows up to the 500-year flow (Figure 31). The elevated bridge deck leaves additional space for debris flow. The 500-year flood depth is approximately 6 feet that leaves about 2.5 feet of freeboard for debris flow. This meets the suggested 20% of bridge opening for debris flow decreasing the risk of clogging from large wood (Furniss et al., 1998).

| ID | Location | Description |
|---|---|---|
| 7 | Northern Tributary Bridge | Elevate road and replace bridge with 30 foot span bridge |

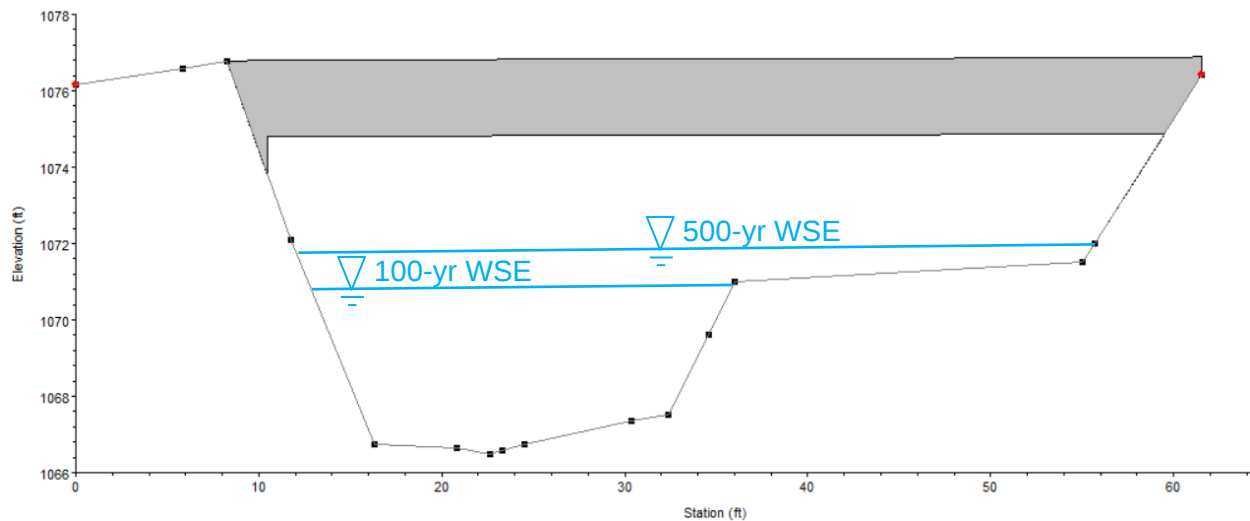
**Figure 32: Model results for elevated 50 foot span bridge**

The 100- and 500-year water surface elevations are similar to Alternative 7 providing the same amount of freeboard for debris flow (Figure 32). However the area for additional flow and debris passage is larger with a flood bench. In the event of debris clogging, the wider span provides more capacity for passage of flood flow and other debris. This wider bridge and flood bench is a more resilient alternative.

| ID | Location | Description |
|---|---|---|
| 8 | Northern Tributary Bridge | Elevate road and replace bridge with 50 foot span bridge |

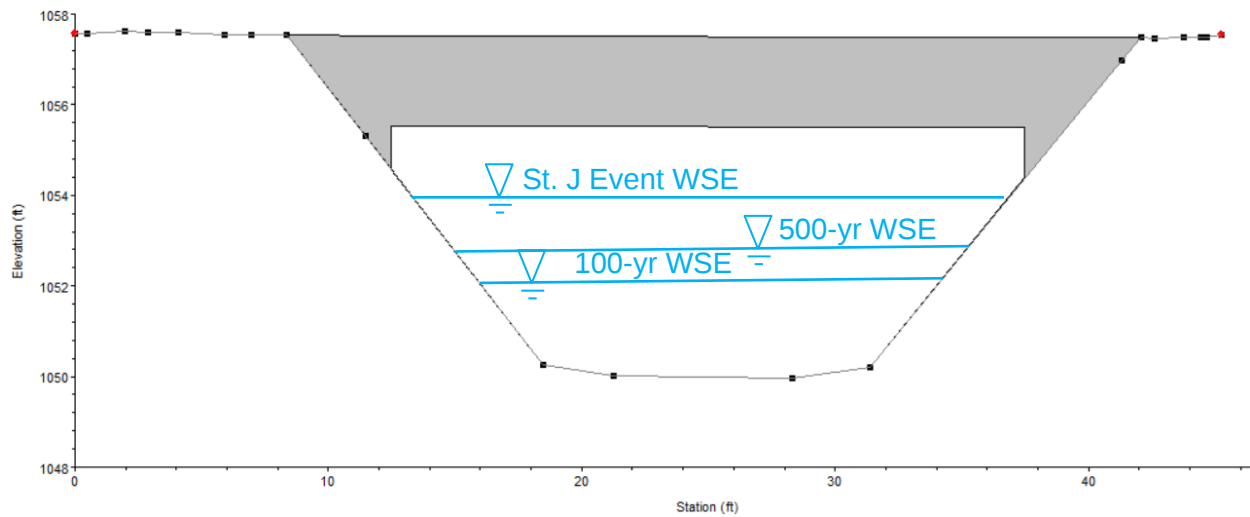
**Figure 33: Model results for Southern Tributary Alternative 3 – 30 foot span bridge**

The hydraulic model was run for the existing conditions and the preferred alternatives for each tributary – Alternatives 3 and 8. The proposed bridge on each tributary passes the modeled flood flow without overtopping (Figure 33 and Figure 34). . Flood inundation of adjacent

buildings and roads does occur during this event for the modeled alternatives (Appendix B). Flood flows in the Southern Tributary overflow the banks behind the Willey Building inundating the parking lot and flowing across Main Street. The Willey Building and buildings on the west side of Main Street would begin to experience inundation. Flood flows in the Northern Tributary escape the channel upstream of the bridge and begin to inundate the nearby homes. On the western side of the road inundation begins to impact the homes from the low lying floodplain of the Winooski River. Although both structures are able to pass the clear flood flow, freeboard is reduced and risks of debris becoming trapped on the bridge deck increase. The modeling shows that the structures are capable of passing an extreme flood. Flooding issues would arise as the upstream and downstream channels are unable to carry a flood event of this size. A storm of this size appears to be exceeding the capacity of the tributaries to pass flow through the village without flooding.
